9 JOPPA ROAD PORTOBELLO EAST EDINBURGH EH15 2HA

Home Report

Scottish
Single Survey

Survey Report

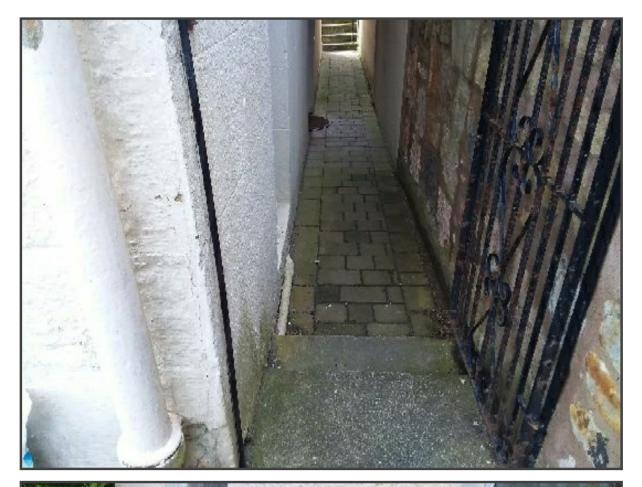
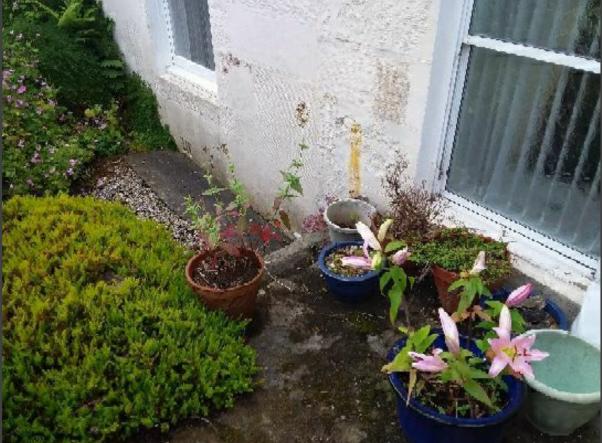
The external ground level in some areas are higher than the finished floor level internally, this could cause penetrating damp.

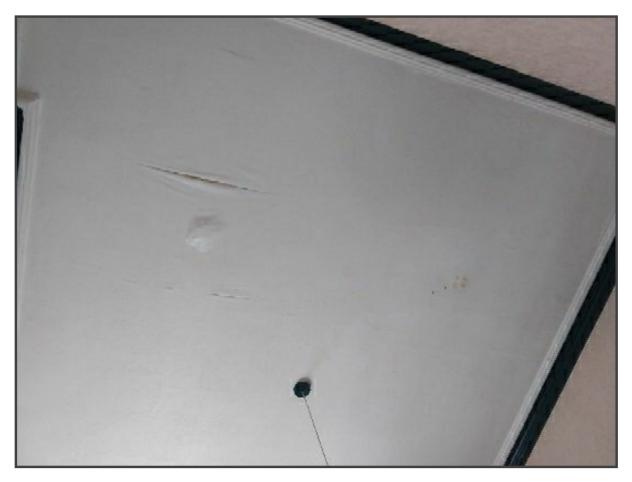
Some water staining was noted to the ceiling within the room rear left, however observations from within the roof void did not indicate any fungal decay.

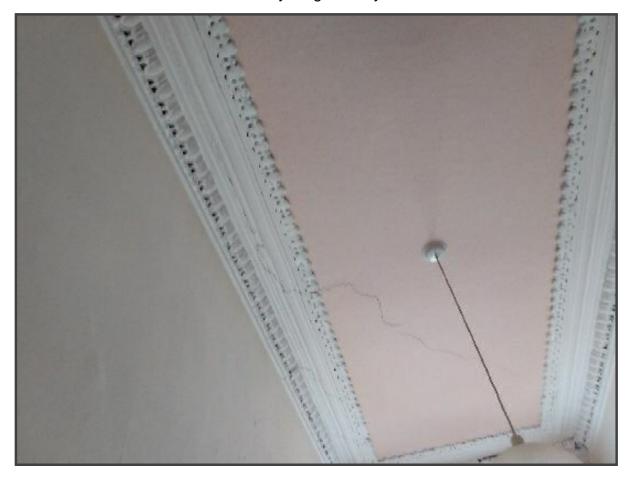
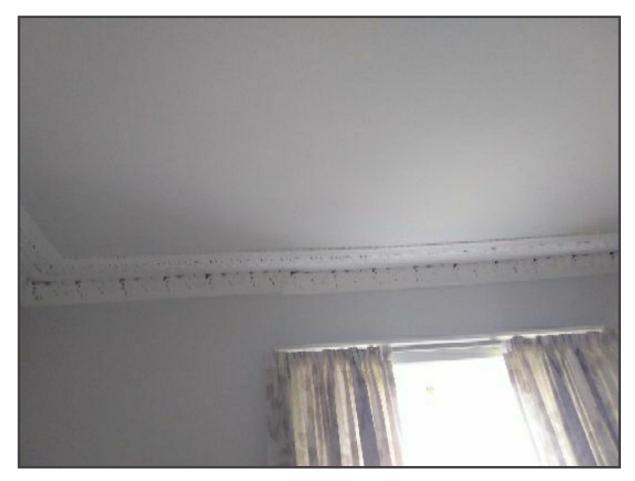
Some cracking and distortion was noted to the ceiling and cornice within the front rooms.
