HOME REPORT

**11 ALMONDBANK TERRACE
EDINBURGH
EH11 1SR**

INSPECTION DATE:

9TH FEBRUARY 2026

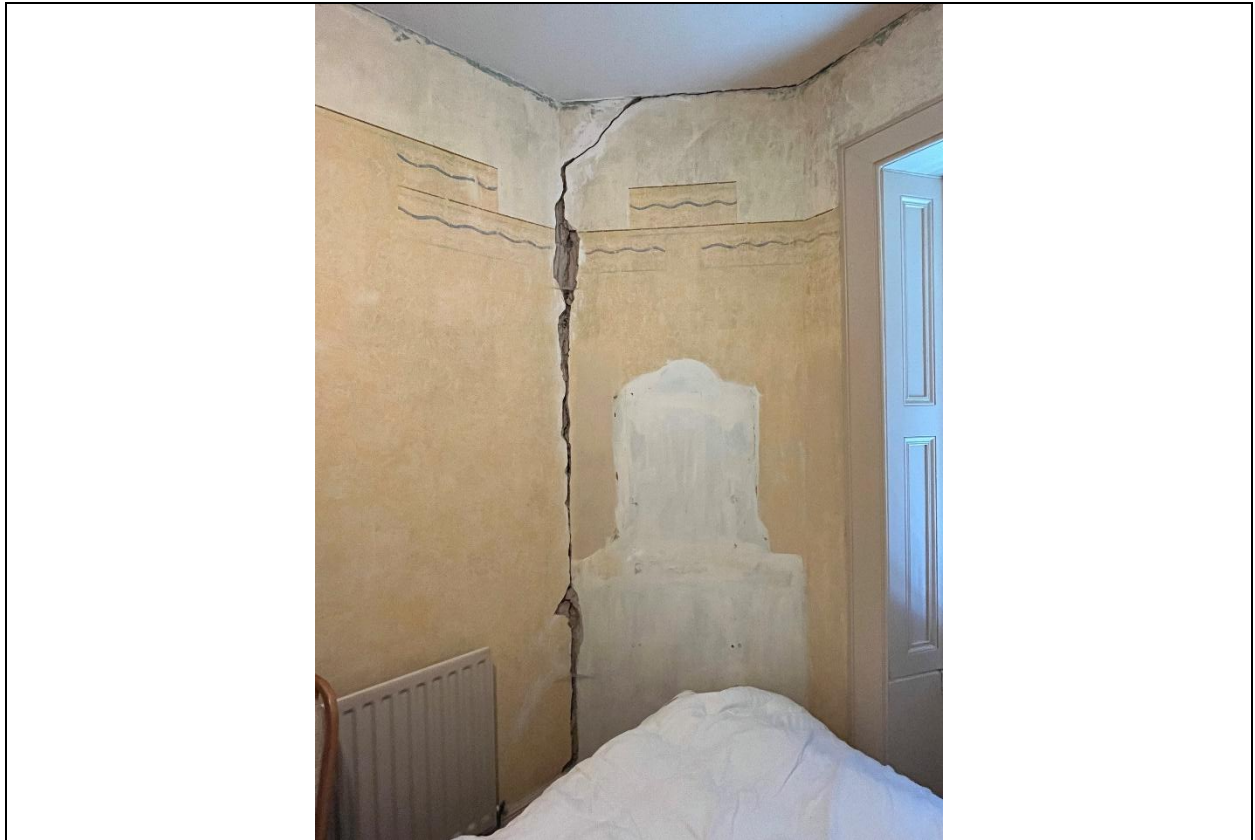
Figure 1 – Pronounced vertical crack to bedroom external/party wall.

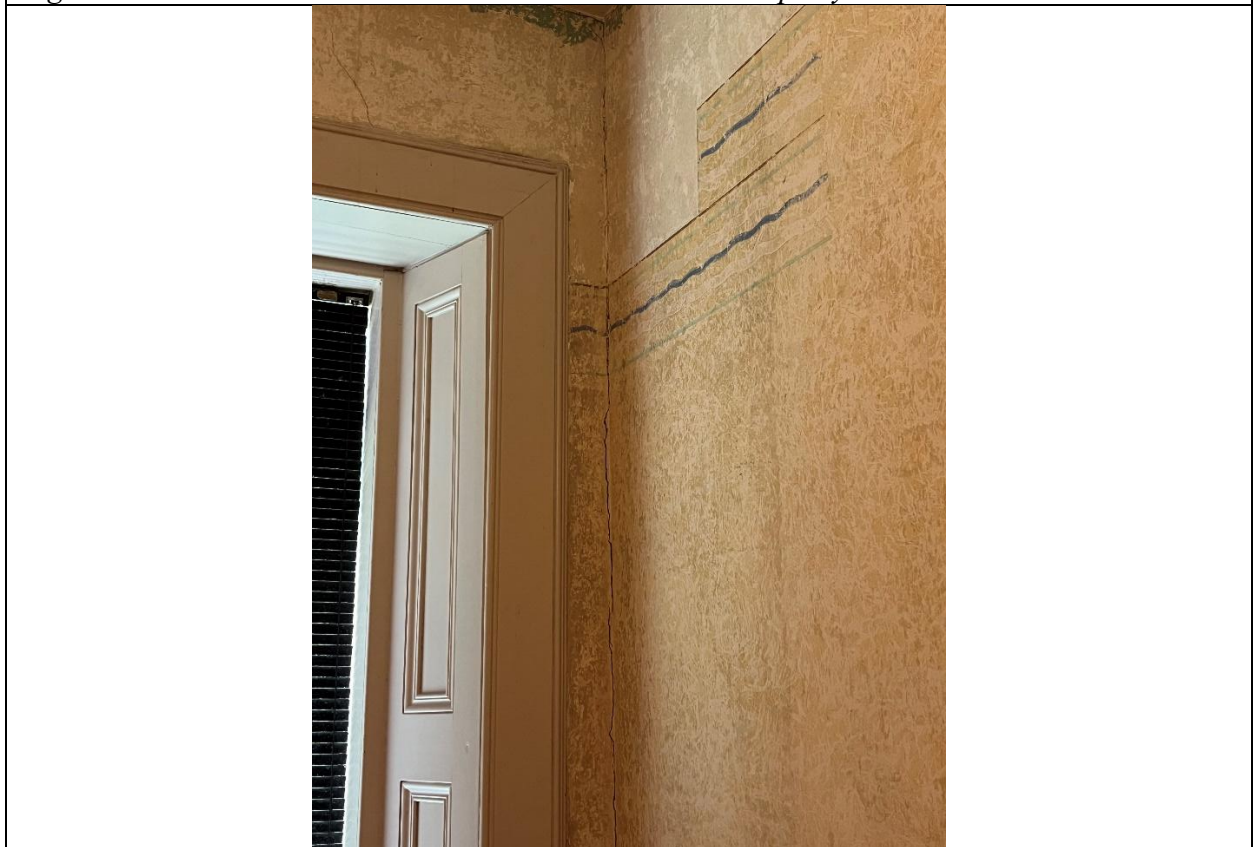
Figure 2 – Vertical crack to bedroom/bathroom wall.

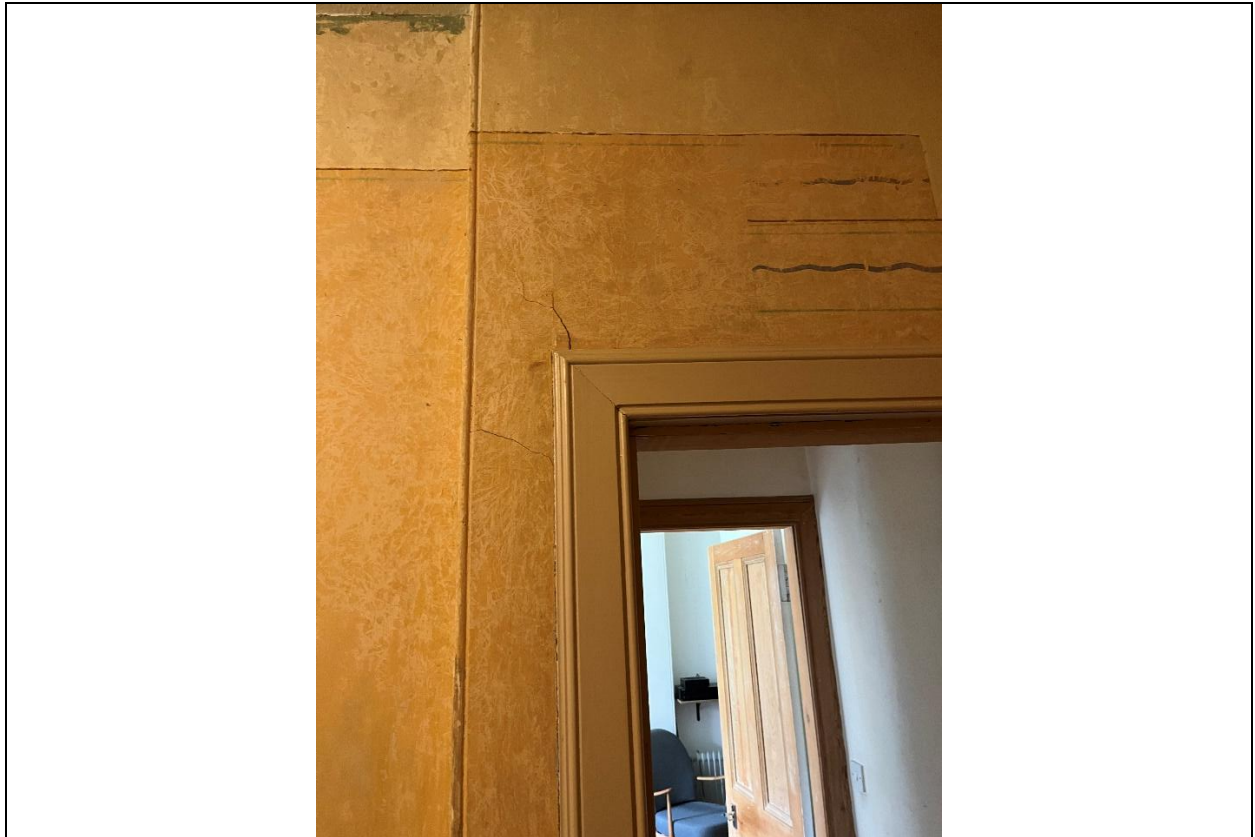
Figure 3 – Minor cracking around bedroom door frame.

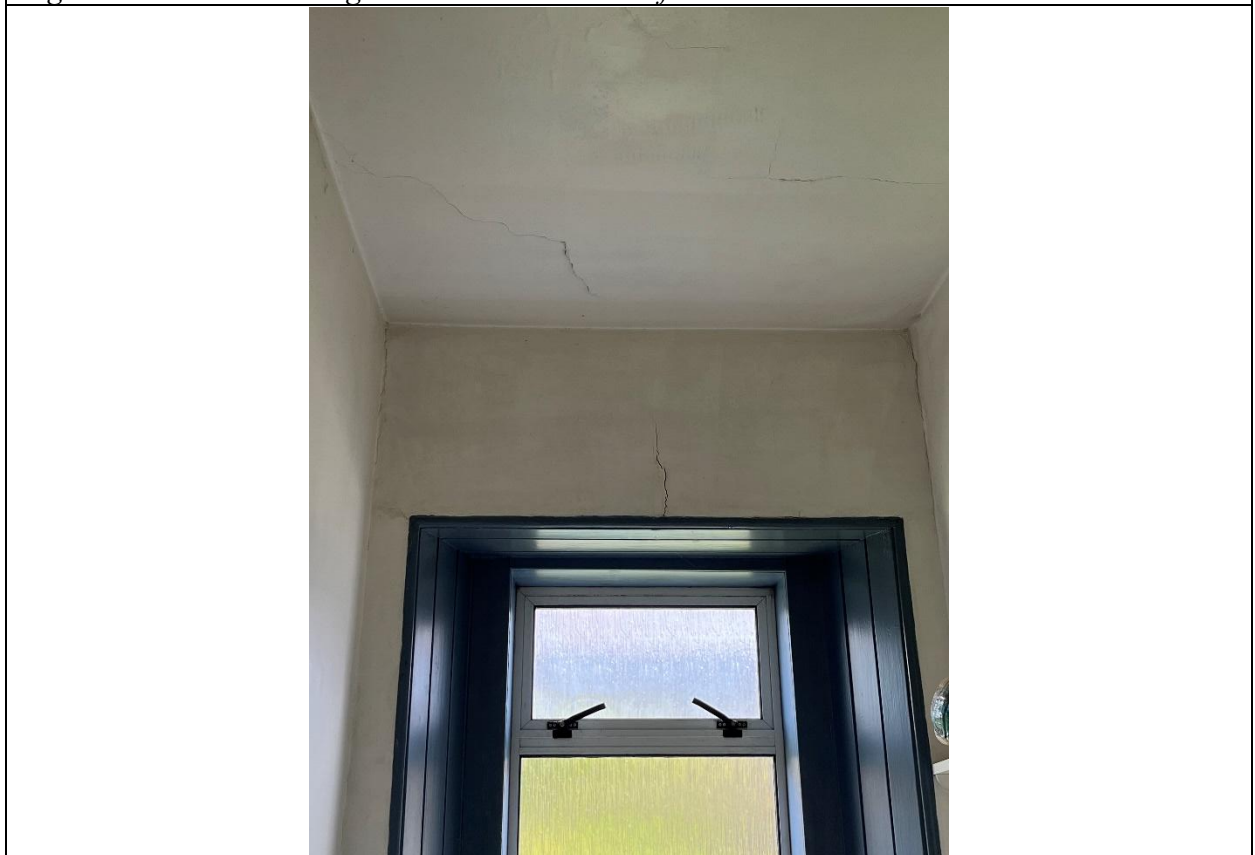
Figure 4 – Vertical crack over bathroom window.

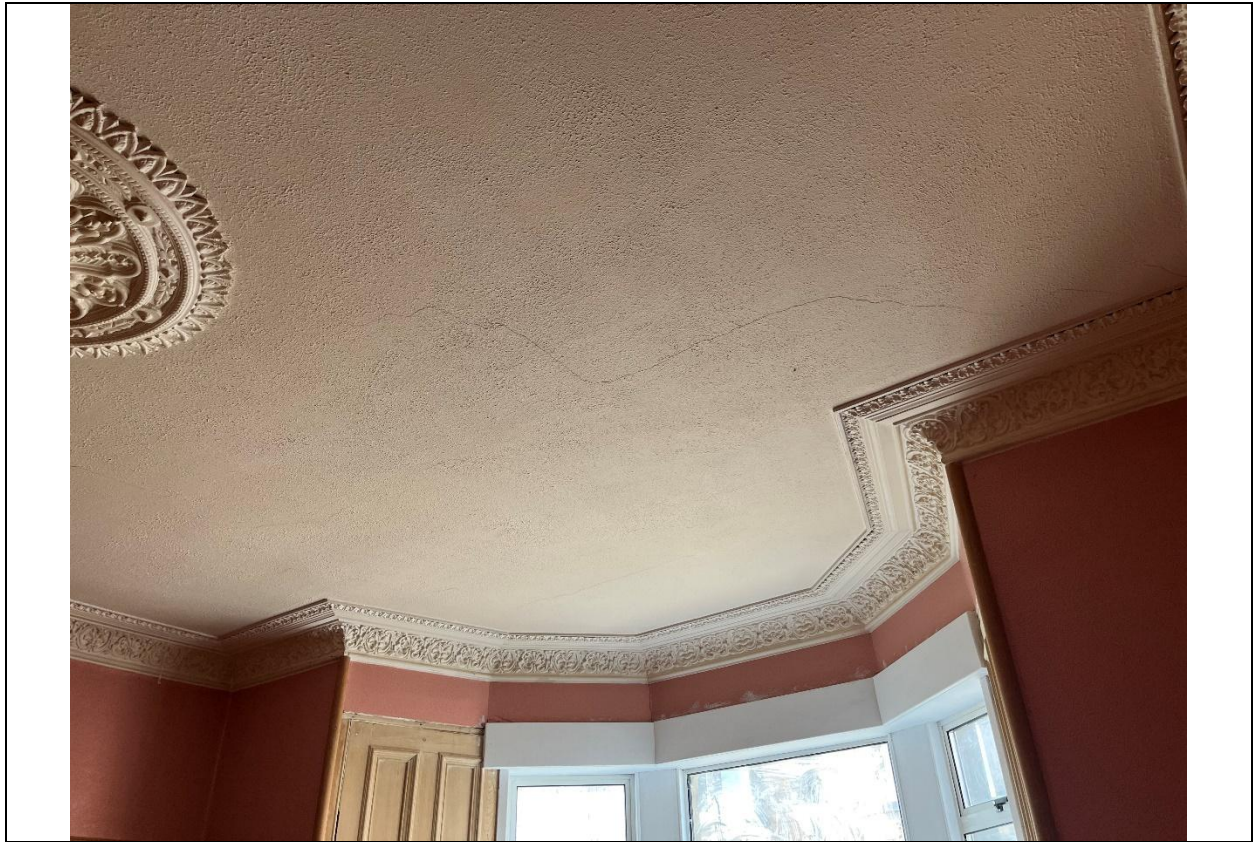
Figure 5 – Typical non-structural cracking to ceilings.

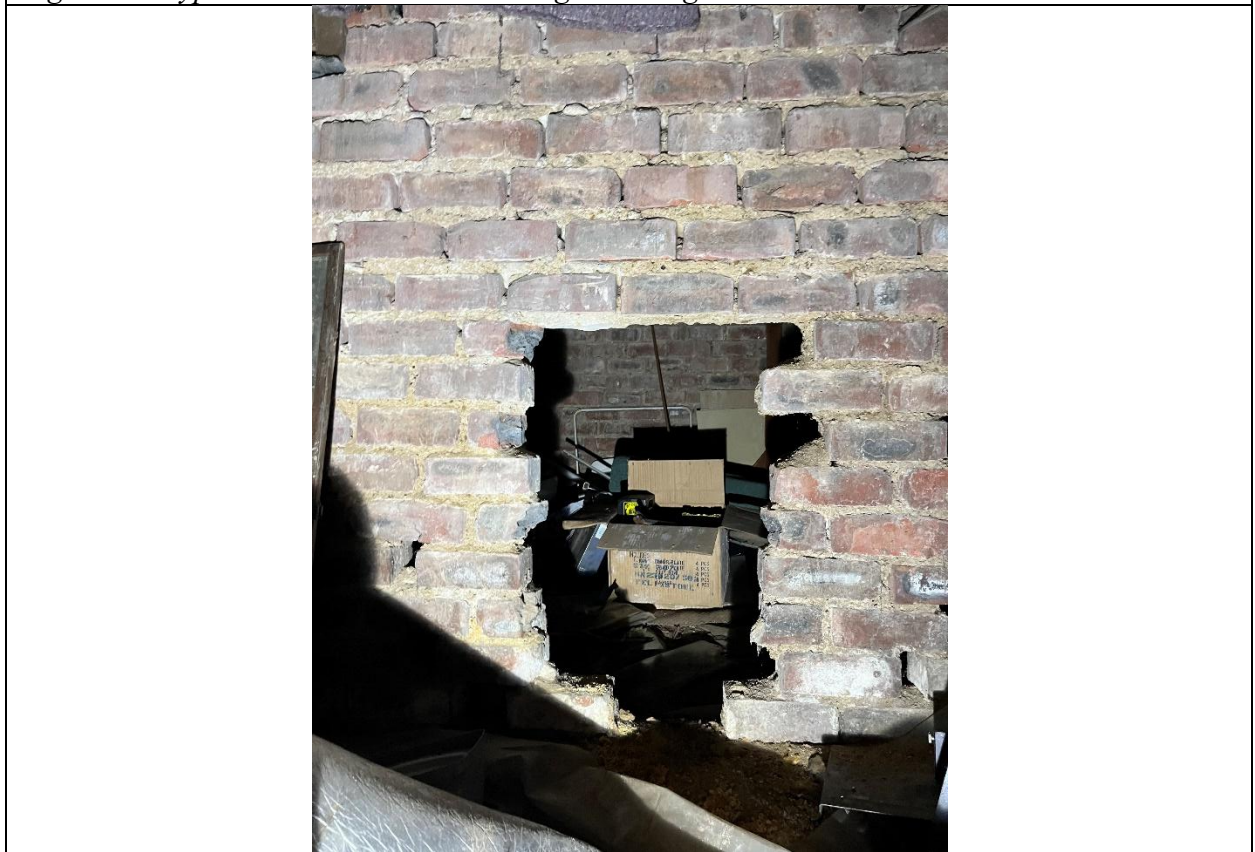
Figure 6 – Typical formed opening in underbuilding walls.

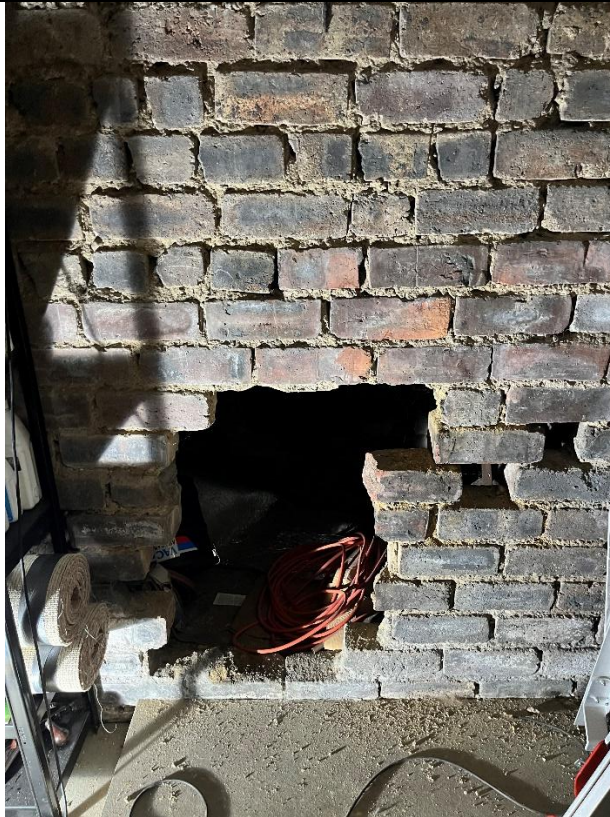
Figure 7 – Typical formed opening in underbuilding walls.

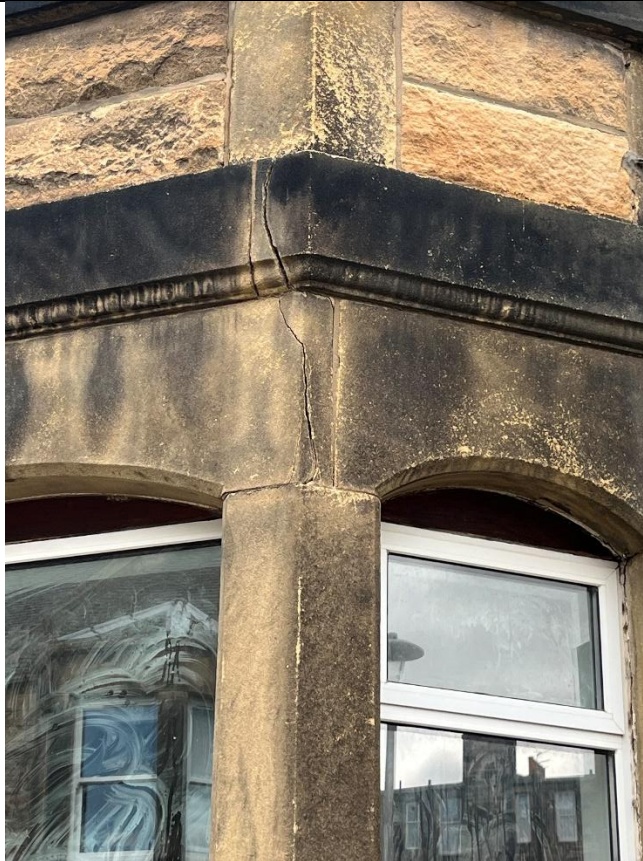
Figure 8 – Cracking to bay-window lintel bearing.
