13 PF2,  
Watson Crescent,  
Edinburgh,  
EH11 1HB

# Home Report

# Single Survey

| <b>Reference</b> | 1273296 |

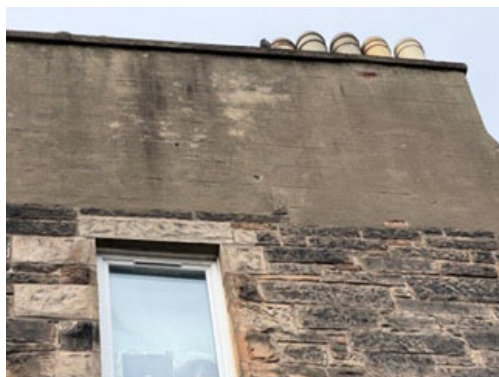
Weathered render

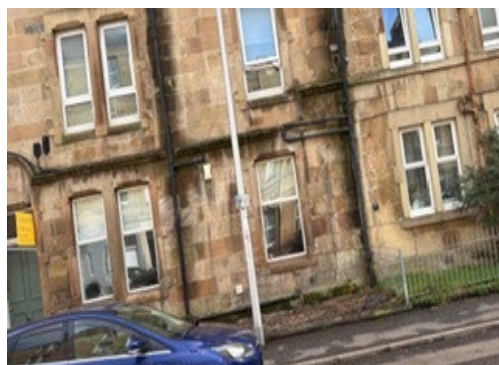
At the time of our initial inspection, it was dry. In view of the fine weather conditions it was not possible to accurately comment as to the efficacy of the existing rainwater goods, although there was clear evidence of significant damp staining around the front elevation down-pipes.

Damp staining attributed to defective rainwater goods

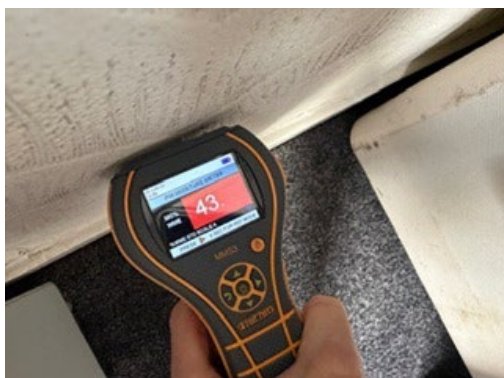
- The lack of effective, or breakdown of an existing, damp proof course.
- Possible bridging of damp proof course between the solid floor and the wall plaster/render, due to the close (relative to bedroom wall only)
- Salt damp in close proximity to the former fireplace in the living room.
- Condensation.

Elevated damp readings  
noted on bedroom wall  
mutual with the close

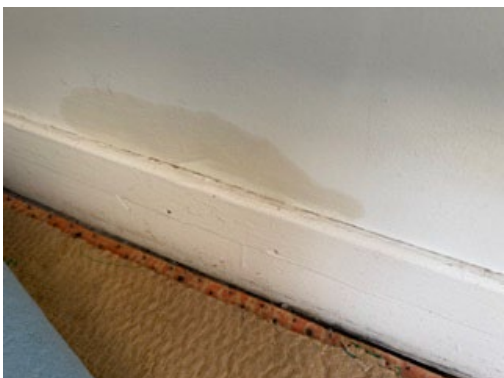
- A significant isolated damp section was noted on the bedroom wall mutual with the living room, and this may be attributed to a leak or former leak from the radiator(s) given the evidence of pipe corrosion.
- In the course of this investigation relative to damp, we paired the carpet back and noted wood weevil in the carpet gripper and flooring ends affected by wet rot where abutting the wall, even though joist and flooring repairs have been undertaken by others previously.

Damp stain and highly  
elevated readings noted on  
bedroom wall mutual with  
living room

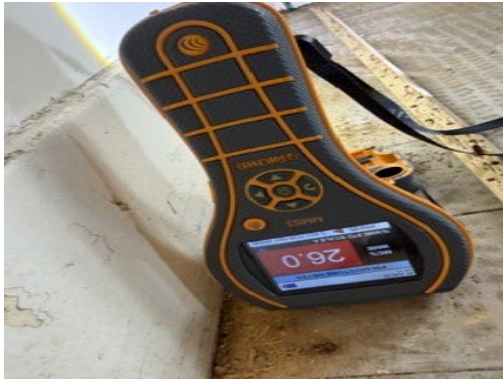
Elevated damp readings in  
flooring and skirting  
bedroom

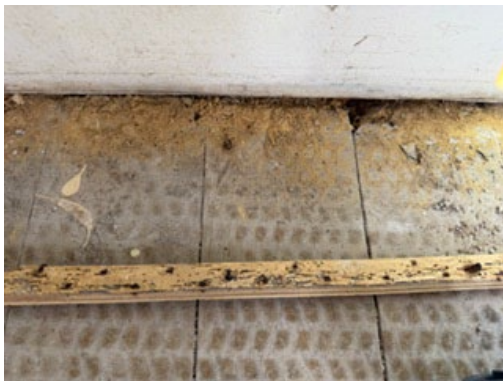
Wood weevil in carpet  
gripper and flooring

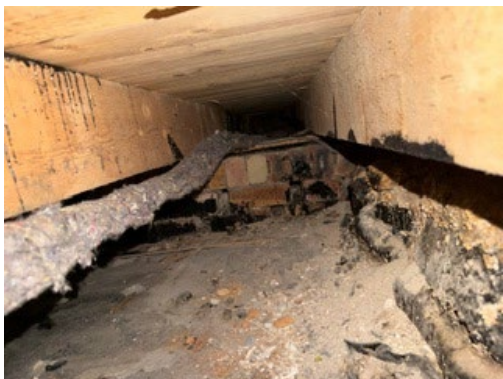
Sub floor joist repairs have  
been carried out previously  
(bedroom)

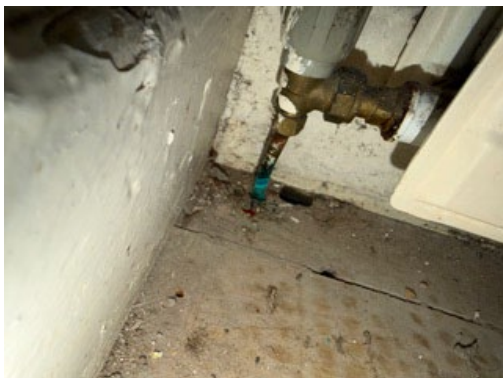
Corrosion to radiator  
microbore

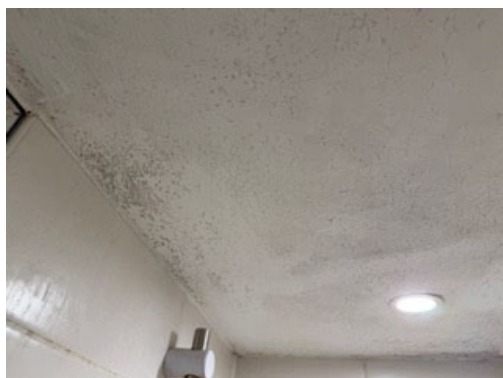
The ceiling surfaces within the shower room were noted to be affected by black spot mould, due to excessive condensation. Condensation occurs when warm moisture-laden air, cools to 'dew-point' (the temperature at which moisture condenses) against a cold surface. Intermittent heating and insufficient ventilation provide ideal conditions for condensation. As such, proper heating and ventilation must be maintained, to reduce moisture available for evaporation into the air within the property and condensing on the cold wall surfaces.

Black spot condensation  
mould in shower room
