Home Report

6/8 North Hillhousefield
Edinburgh EH6 4HU

Date of Valuation: 27/05/2026

Property Address	6/8 North Hillhousefield Edinburgh EH6 4HU
Customer	Jillian Pearson
Prepared by	Graham + Sibbald Property Consultants Limited
Date of Inspection	27/05/2026

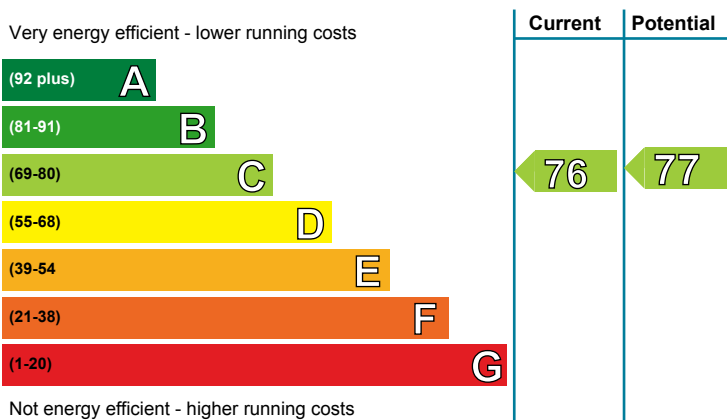
Energy Efficiency Rating

Your current rating is **band C (76)**. The average rating for EPCs in Scotland is **band D (61)**.

Recommended measures	Indicative cost	Typical savings over 3 years
1 Increase loft insulation to 270 mm	£900 - £1,200	£153.00
