Home Report

16/2 Jessfield Terrace
Edinburgh EH6 4JP

Single Survey

Date of Inspection	01/10/2026

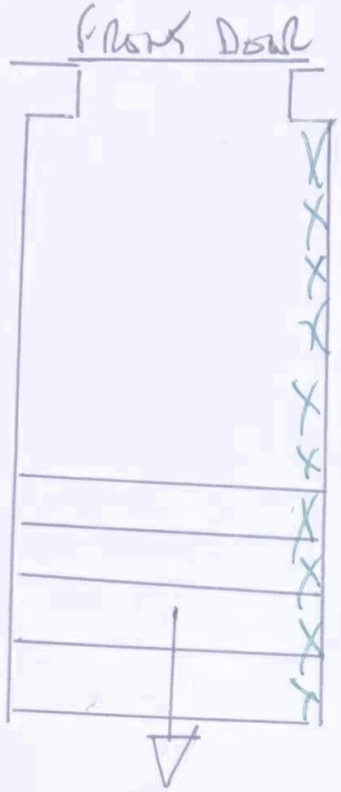
16/2 JESSFIELD TERRACE

Dampness, Rot and Infestation
Repair Category	**2**
Notes	Some elevated moisture readings noted to the lower ground at the entrance hall. Kingston Preservation have carried out a survey on 7th October 2026. They have quoted for repairs works including the installation of a new DPC. Full details and costs should be sought.

XXXXX DAMP WALLS TO BE TREATED
