13 PF2,  
Watson Crescent,  
Edinburgh,  
EH11 1HB

# Home Report

# Single Survey

| <b>Reference</b> | 1273296 |

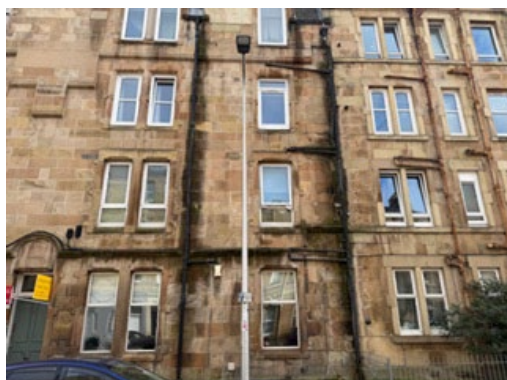
Front elevation

At the time of our initial inspection, it was dry. In view of the fine weather conditions it was not possible to accurately comment as to the efficacy of the existing rainwater goods, although there was clear evidence of significant damp staining around the front elevation down-pipes.

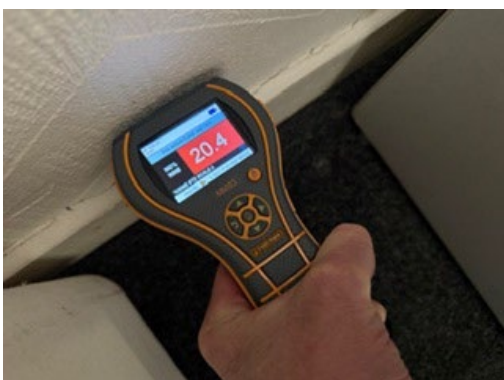
Elevated damp readings  
noted on bedroom wall  
mutual with the close

- A significant isolated damp section was noted on the bedroom wall mutual with the living room, and this may be attributed to a leak or former leak from the radiator(s) given the evidence of pipe corrosion.
- In the course of this investigation relative to damp, we paired the carpet back and noted wood weevil in the carpet gripper and flooring ends affected by wet rot where abutting the wall, even though joist and flooring repairs have been undertaken by others previously.
