HOME report

SINGLE SURVEY
ENERGY REPORT
PROPERTY QUESTIONNAIRE
VALUATION REPORT

Property address	1 Glen Roy Place, Kirkcaldy, Fife, KY2 6UP
-------------------------	---

Prepared by	Harvey Donaldson And Gibson
--------------------	-----------------------------

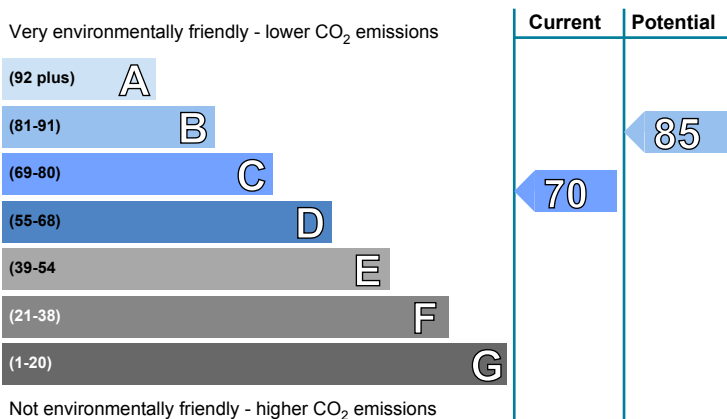
Environmental Impact (CO₂) Rating

This graph shows the effect of your home on the environment in terms of carbon dioxide (CO₂) emissions. The higher the rating, the less impact it has on the environment.
