## HOME REPORT

4 Oxford Street  
DUNDEE  
DD2 1TJ  
02/12/2016

# Single Survey

<b>Property address</b>	4 Oxford Street Dundee DD2 1TJ
<b>Customer</b>	Executors of the Late Mr J Moreland
<b>Customer address</b>	c/o Miller Hendry, Solicitors LP - 40 Dundee
<b>Prepared by</b>	J & E Shepherd
<b>Date of inspection</b>	24th November 2016

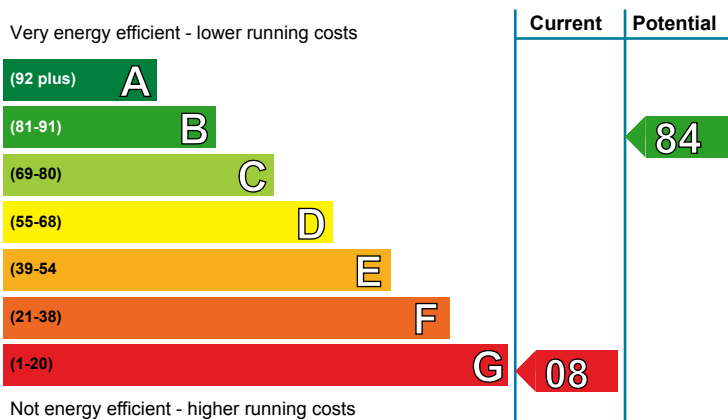
## Energy Efficiency Rating

This graph shows the current efficiency of your home, taking into account both energy efficiency and fuel costs. The higher this rating, the lower your fuel bills are likely to be.

Your current rating is **band G (8)**. The average rating for EPCs in Scotland is **band D (61)**.

The potential rating shows the effect of undertaking all of the improvement measures listed within your recommendations report.

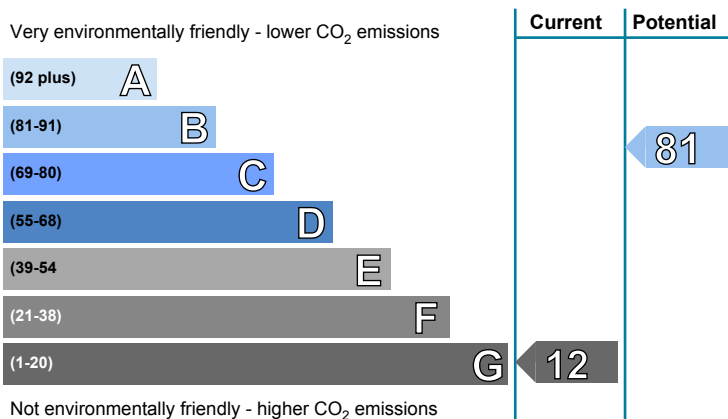
## Environmental Impact (CO<sub>2</sub>) Rating

This graph shows the effect of your home on the environment in terms of carbon dioxide (CO<sub>2</sub>) emissions. The higher the rating, the less impact it has on the environment.
