54 William Street Blairgowrie PH10 6BH

# home report index

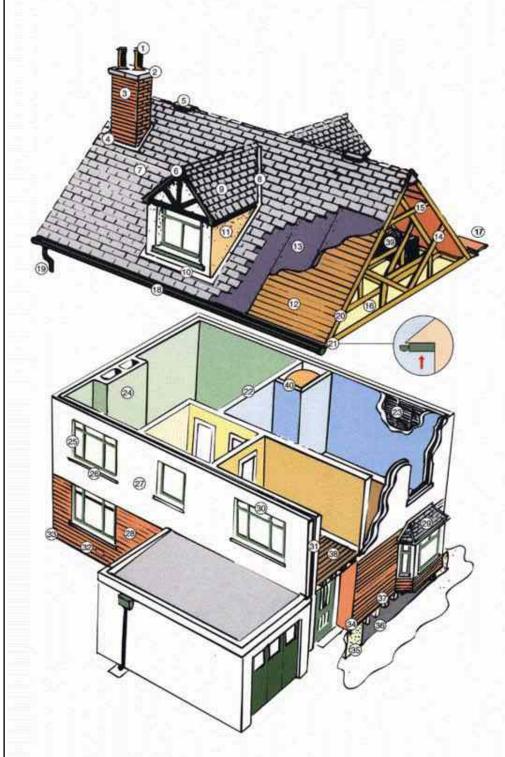
## Sectional Diagram showing elements of a typical house

Reference may be made in this report to some or all of the above component parts of the property. This diagram may assist you in locating and understanding these items.

- 1) Chimney pots
- (2) Coping stone
- 3) Chimney head
- 4) Flashing
- (5) Ridge ventilation
- 6) Ridge board
- 7) Slates / tiles
- (8) Valley guttering
- 9) Dormer projection
- 10 Dormer flashing
- 11) Dormer cheeks
- 12) Sarking
- (13) Roof felt
- (14) Trusses
- 15) Collar
- (16) Insulation
- 7) Parapet gutter
- 18) Eaves guttering
- 19) Rainwater downpipe
- 0) Verge boards /skews
- 21) Soffit boards
- 22) Partition wall
- 23) Lath / plaster
- 24) Chimney breast
- (25) Window pointing
- Window sills
- (27) Rendering
- 28) Brickwork / pointing
- 29) Bay window projection
- (30) Lintels
- (31) Cavity walls / wall ties
- 32) Subfloor ventilator
- 33) Damp proof course
- 34) Base course
- 35) Foundations
- 36) Solum
- 37) Floor joists
- 38) Floorboards
- 9) Water tank
- 40) Hot water tank
