HOME REPORT

22 Selkirk Gardens
DUNDEE
DD4 0JZ
27/02/2019

Single Survey

Prepared by	Graham + Sibbald
--------------------	------------------

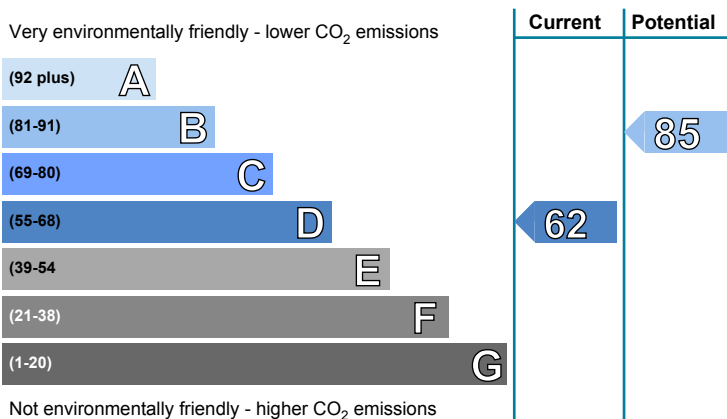
Environmental Impact (CO₂) Rating

This graph shows the effect of your home on the environment in terms of carbon dioxide (CO₂) emissions. The higher the rating, the less impact it has on the environment.
