HOME REPORT

10 King Street
Broughty Ferry
DUNDEE
DD5 1HE
17/05/2019

Single Survey

Property address	10 King Street Broughty Ferry Dundee DD5 1HE
Customer	Mr M Wallace
Customer address	C/o Miller Hendry Estate Agents 13 Ward Road Dundee DD1 1LU
Prepared by	J & E Shepherd
Date of inspection	10th May 2019

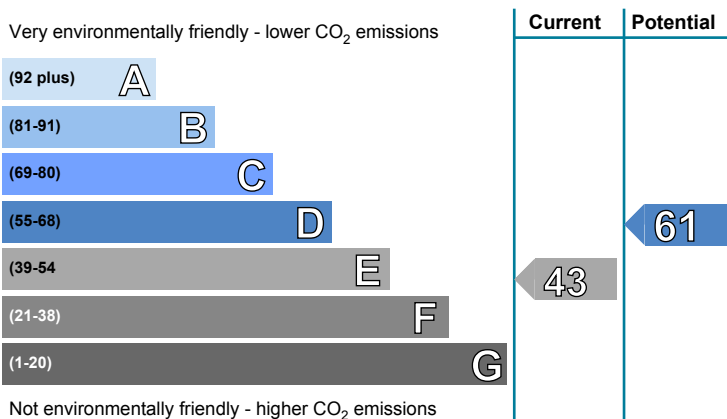
Environmental Impact (CO₂) Rating

This graph shows the effect of your home on the environment in terms of carbon dioxide (CO₂) emissions. The higher the rating, the less impact it has on the environment.
