HOME REPORT

G/R 319 Clepington Road
DUNDEE
DD3 8BD
31/05/2019

Single Survey

Property address	G/2 319 Clepington Road Dundee DD3 8BD
Customer	Mrs J Kydd
Customer address	c/o Miller Hendry 13 Ward Road Dundee DD1 1LU
Prepared by	Graham & Sibbald
Date of inspection	23rd May 2019

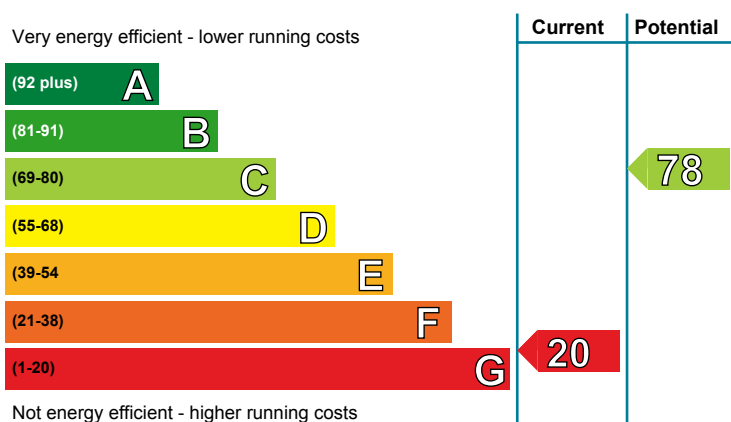
Energy Efficiency Rating

This graph shows the current efficiency of your home, taking into account both energy efficiency and fuel costs. The higher this rating, the lower your fuel bills are likely to be.

Your current rating is **band G (20)**. The average rating for EPCs in Scotland is **band D (61)**.

The potential rating shows the effect of undertaking all of the improvement measures listed within your recommendations report.

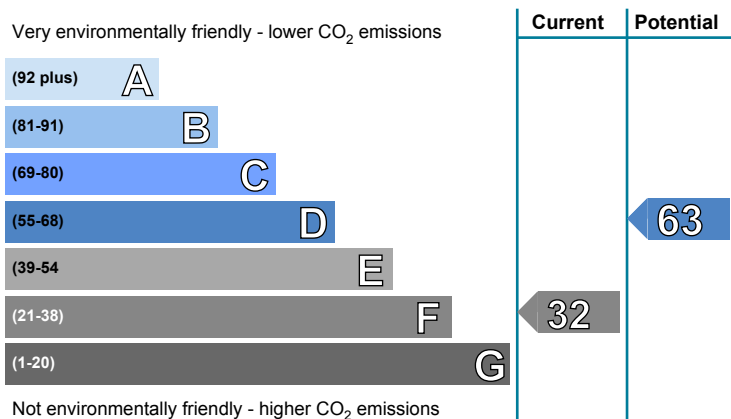
Environmental Impact (CO₂) Rating

This graph shows the effect of your home on the environment in terms of carbon dioxide (CO₂) emissions. The higher the rating, the less impact it has on the environment.
