HOME REPORT

117 Main Street
Longforgan
DUNDEE
DD2 5HB
12/09/2019

Single Survey

Property address	An Cala 117 Main Street Longforgan Dundee DD2 5HB
Customer	Ms Roslyn Cameron
Customer address	c/o Miller Hendry 13 Ward Road Dundee DD1 1LU
Prepared by	Graham & Sibbald
Date of inspection	10th September 2019

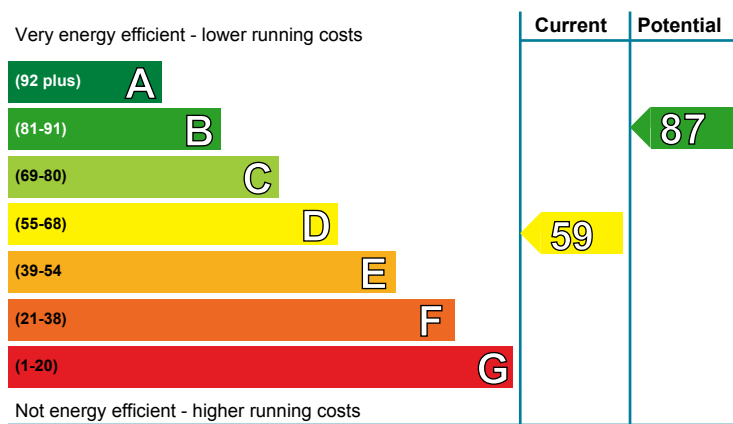
Energy Efficiency Rating

This graph shows the current efficiency of your home, taking into account both energy efficiency and fuel costs. The higher this rating, the lower your fuel bills are likely to be.

Your current rating is **band D (59)**. The average rating for EPCs in Scotland is **band D (61)**.

The potential rating shows the effect of undertaking all of the improvement measures listed within your recommendations report.

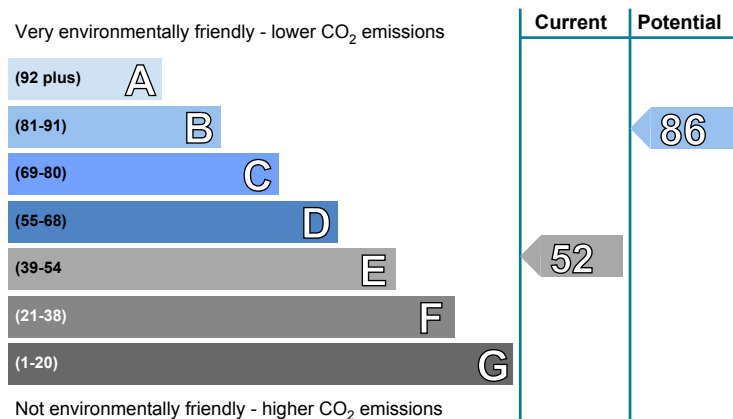
Environmental Impact (CO₂) Rating

This graph shows the effect of your home on the environment in terms of carbon dioxide (CO₂) emissions. The higher the rating, the less impact it has on the environment.
