HOME REPORT

4 Kilburn
NEWPORT-ON-TAY
DD6 8DE
01/08/2019

Single Survey

Property address	4 Kilburn Newport On Tay DD6 8DE
Customer	Ms T Durham
Customer address	C/o Miller Hendry 13 Ward Road Dundee DD1 1LU
Prepared by	ALLIED SURVEYORS SCOTLAND PLC
Date of inspection	29th July 2019

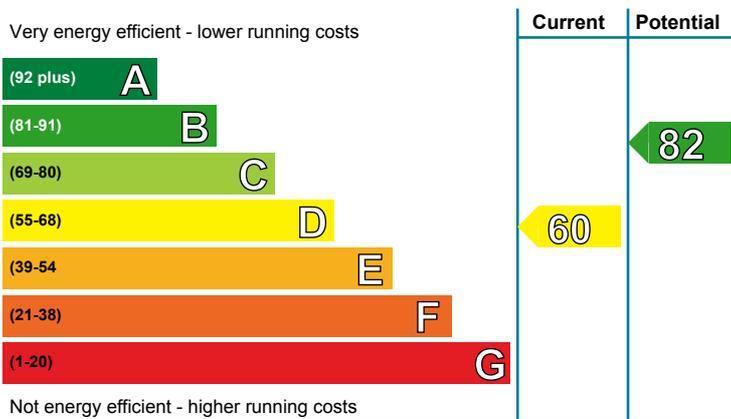
Energy Efficiency Rating

This graph shows the current efficiency of your home, taking into account both energy efficiency and fuel costs. The higher this rating, the lower your fuel bills are likely to be.

Your current rating is **band D (60)**. The average rating for EPCs in Scotland is **band D (61)**.

The potential rating shows the effect of undertaking all of the improvement measures listed within your recommendations report.

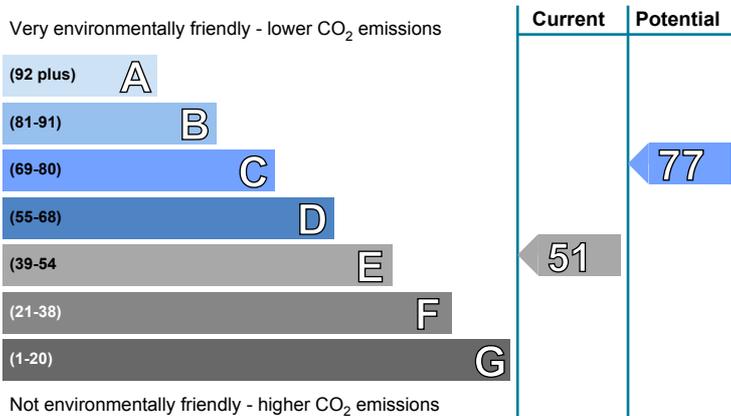
Environmental Impact (CO₂) Rating

This graph shows the effect of your home on the environment in terms of carbon dioxide (CO₂) emissions. The higher the rating, the less impact it has on the environment.
