HOME REPORT

76 Mains Drive
DUNDEE
DD4 9BW
24/07/2020

Single Survey

Prepared by	Graham & Sibbald
--------------------	------------------

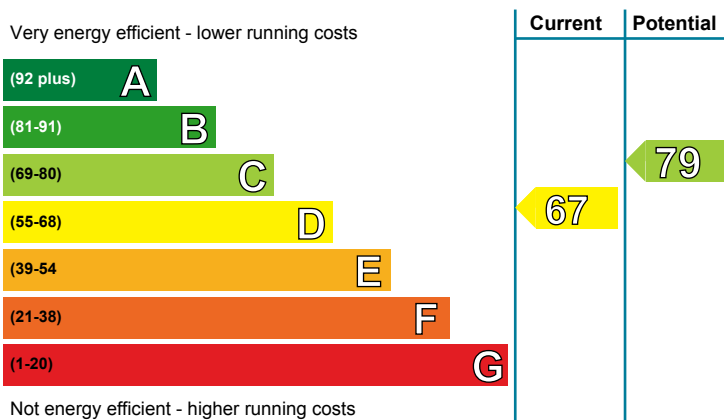
Energy Efficiency Rating

This graph shows the current efficiency of your home, taking into account both energy efficiency and fuel costs. The higher this rating, the lower your fuel bills are likely to be.

Your current rating is **band D (67)**. The average rating for EPCs in Scotland is **band D (61)**.

The potential rating shows the effect of undertaking all of the improvement measures listed within your recommendations report.

Estimated energy costs for your home for 3 years*	£2,436	See your recommendations report for more information
Over 3 years you could save*	£939

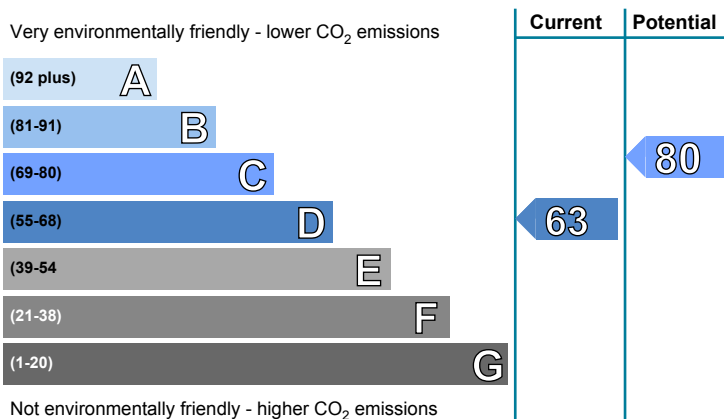
Environmental Impact (CO₂) Rating

This graph shows the effect of your home on the environment in terms of carbon dioxide (CO₂) emissions. The higher the rating, the less impact it has on the environment.
