HOME REPORT

10 Grey Street
TAYPORT
DD6 9HW
08/08/2019

Single Survey

Property address	10 Grey Street Tayport DD6 9HW
Customer	Ms S Arnold
Customer address	c/o Miller Hendry 13 Ward Road Dundee DD1 1LU
Prepared by	Graham & Sibbald
Date of inspection	6th August 2019

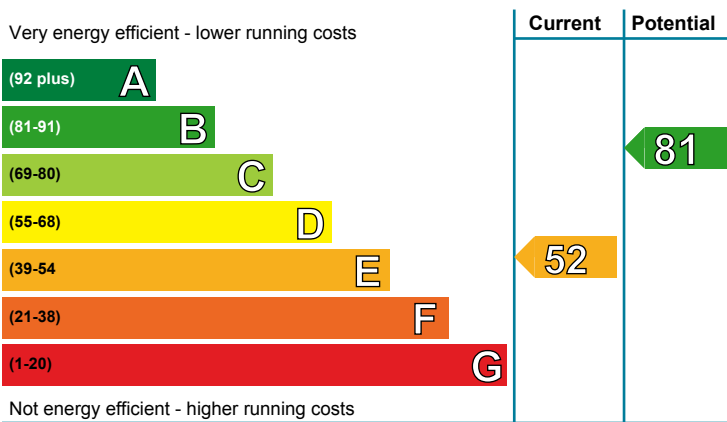
Energy Efficiency Rating

This graph shows the current efficiency of your home, taking into account both energy efficiency and fuel costs. The higher this rating, the lower your fuel bills are likely to be.

Your current rating is **band E (52)**. The average rating for EPCs in Scotland is **band D (61)**.

The potential rating shows the effect of undertaking all of the improvement measures listed within your recommendations report.

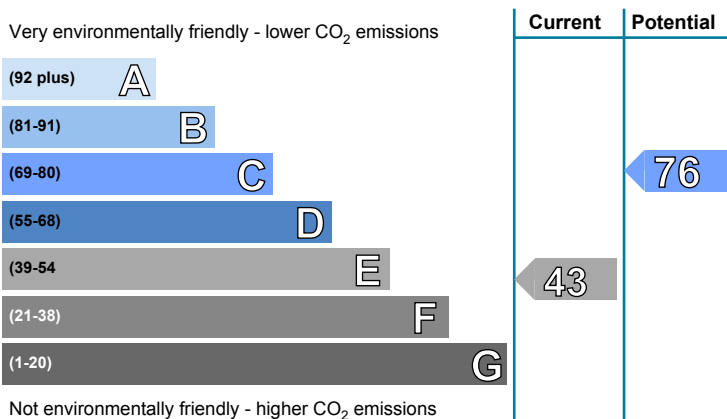
Environmental Impact (CO₂) Rating

This graph shows the effect of your home on the environment in terms of carbon dioxide (CO₂) emissions. The higher the rating, the less impact it has on the environment.
