# Home Report Index

# Single Survey

<b>Property address</b>	Pinegrove Alyth Road Meigle Blairgowrie PH12 8RP
<b>Customer</b>	Mrs Maureen Milne
<b>Customer address</b>	c/o Blackadders
<b>Prepared by</b>	Graham + Sibbald
<b>Date of inspection</b>	3rd February 2021

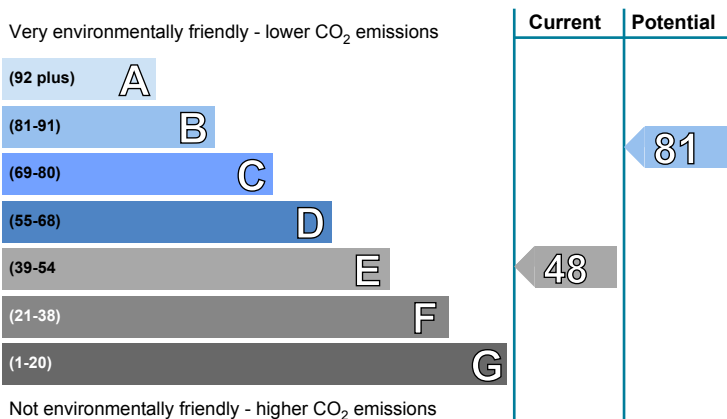
## Environmental Impact (CO<sub>2</sub>) Rating

This graph shows the effect of your home on the environment in terms of carbon dioxide (CO<sub>2</sub>) emissions. The higher the rating, the less impact it has on the environment.
