# Home Report

# Scottish Single Survey

| <b>Property address</b> | 29 Links Walk<br>Port Seton<br>Prestonpans<br>EH32 0TW |

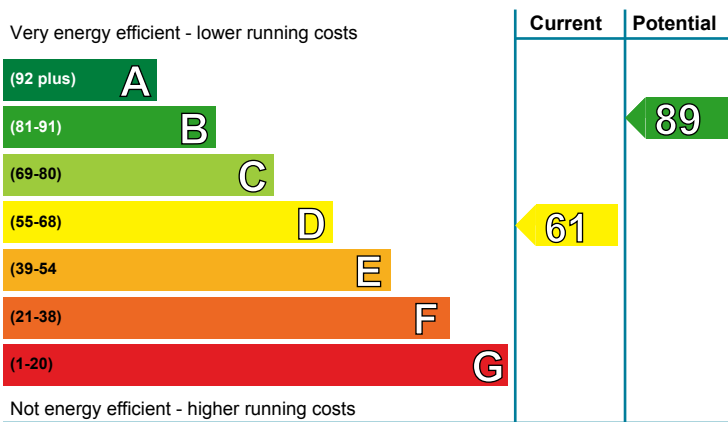
## Energy Efficiency Rating

This graph shows the current efficiency of your home, taking into account both energy efficiency and fuel costs. The higher this rating, the lower your fuel bills are likely to be.

Your current rating is **band D (61)**. The average rating for EPCs in Scotland is **band D (61)**.

The potential rating shows the effect of undertaking all of the improvement measures listed within your recommendations report.

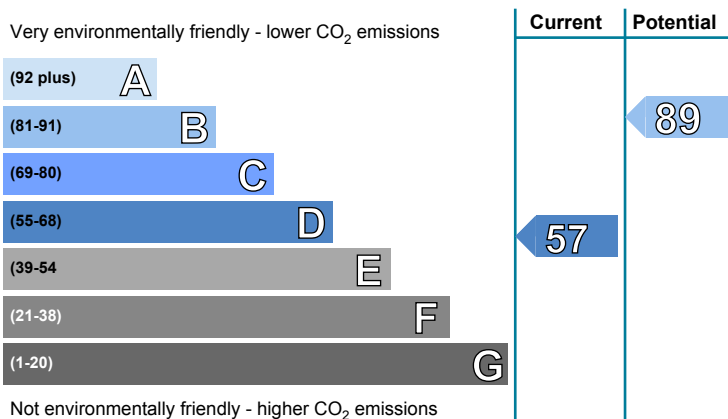
## Environmental Impact (CO<sub>2</sub>) Rating

This graph shows the effect of your home on the environment in terms of carbon dioxide (CO<sub>2</sub>) emissions. The higher the rating, the less impact it has on the environment.
