Home Report

Scottish Single Survey

Single Survey

| Property address | 62 Mayfield Crescent Musselburgh EH21 6HB |

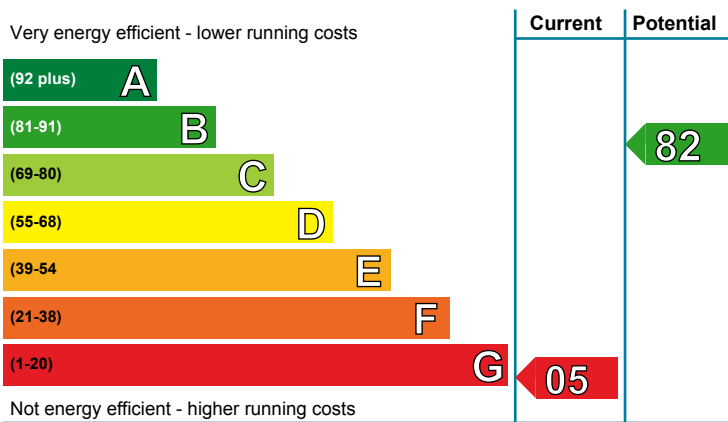
Energy Efficiency Rating

This graph shows the current efficiency of your home, taking into account both energy efficiency and fuel costs. The higher this rating, the lower your fuel bills are likely to be.

Your current rating is **band G (5)**. The average rating for EPCs in Scotland is **band D (61)**.

The potential rating shows the effect of undertaking all of the improvement measures listed within your recommendations report.

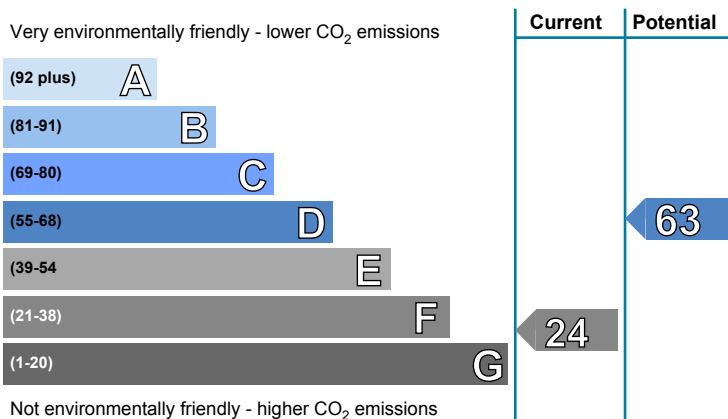
Environmental Impact (CO₂) Rating

This graph shows the effect of your home on the environment in terms of carbon dioxide (CO₂) emissions. The higher the rating, the less impact it has on the environment.
