Home Report

Scottish Single Survey

Property address	9 Stoneyhill Terrace Musselburgh EH21 6SG
Customer	Executors of late Katherine Mackay
Customer address	9 Stoneyhill Terrace Musselburgh EH21 6SG
Prepared by	Shepherd Chartered Surveyors
Date of inspection	03/07/2024

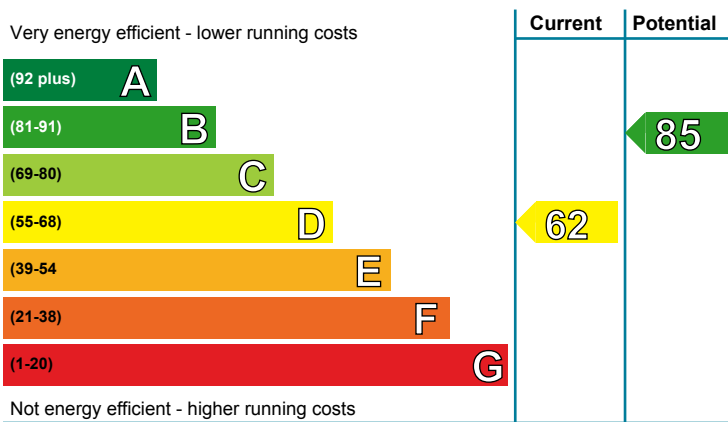
Energy Efficiency Rating

This graph shows the current efficiency of your home, taking into account both energy efficiency and fuel costs. The higher this rating, the lower your fuel bills are likely to be.

Your current rating is **band D (62)**. The average rating for EPCs in Scotland is **band D (61)**.

The potential rating shows the effect of undertaking all of the improvement measures listed within your recommendations report.
