73 RANKIN DRIVE
BLACKFORD
EDINBURGH
EH9 3DG

Home Report

Energy Performance Certificate (EPC)

Single Survey

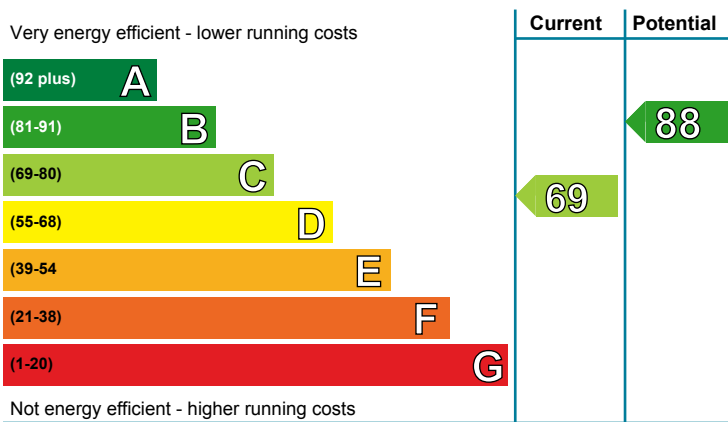
Energy Efficiency Rating

This graph shows the current efficiency of your home, taking into account both energy efficiency and fuel costs. The higher this rating, the lower your fuel bills are likely to be.

Your current rating is **band C (69)**. The average rating for EPCs in Scotland is **band D (61)**.

The potential rating shows the effect of undertaking all of the improvement measures listed within your recommendations report.

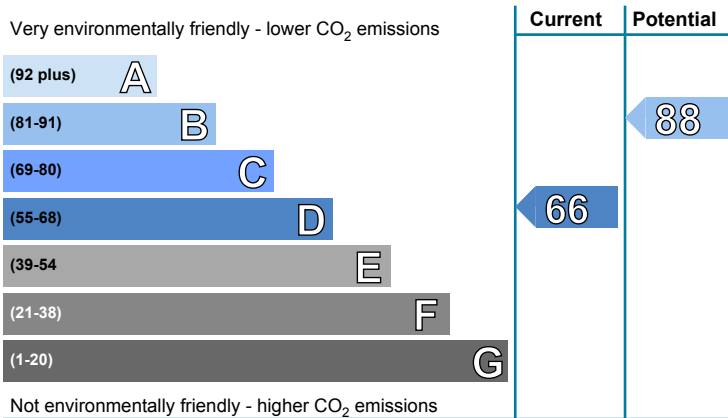
Environmental Impact (CO₂) Rating

This graph shows the effect of your home on the environment in terms of carbon dioxide (CO₂) emissions. The higher the rating, the less impact it has on the environment.

The potential rating shows the effect of undertaking all of the improvement measures listed within your recommendations report.

The average Scottish household produces about 6 tonnes of carbon dioxide every year. Based on this assessment, heating and lighting this home currently produces approximately 3.0 tonnes of carbon dioxide every year. Adopting recommendations in this report can reduce emissions and protect the environment. If you were to install all of these recommendations this could reduce emissions by 1.8 tonnes per year. You could reduce emissions even more by switching to renewable energy sources.
