HOME REPORT

2 ESK MILL VILLAS, STATION ROAD, INVERESK, MUSSELBURGH, EH21 7PG

Dwelling type: Top-floor flat
Date of assessment: 04 July 2024
Date of certificate: 25 July 2024
Total floor area: 124 m²
Primary Energy Indicator: 373 kWh/m²/year

Single Survey

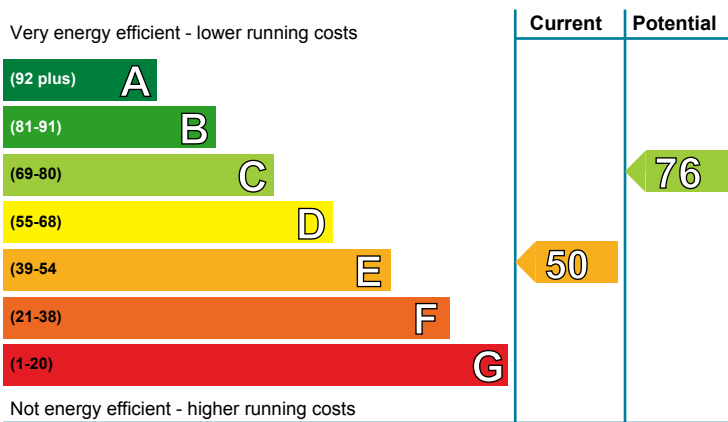
Energy Efficiency Rating

This graph shows the current efficiency of your home, taking into account both energy efficiency and fuel costs. The higher this rating, the lower your fuel bills are likely to be.

Your current rating is **band E (50)**. The average rating for EPCs in Scotland is **band D (61)**.

The potential rating shows the effect of undertaking all of the improvement measures listed within your recommendations report.

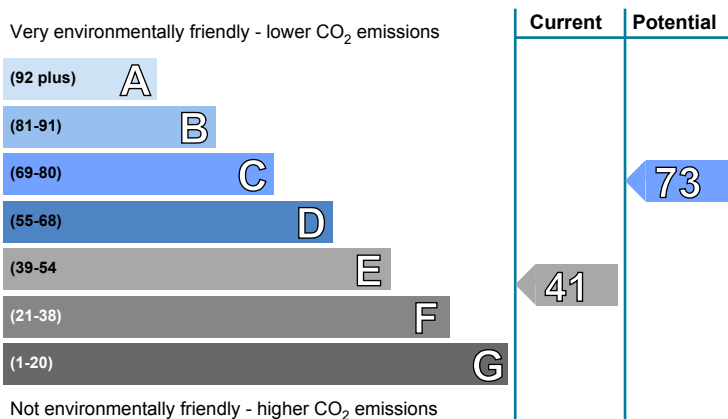
Environmental Impact (CO₂) Rating

This graph shows the effect of your home on the environment in terms of carbon dioxide (CO₂) emissions. The higher the rating, the less impact it has on the environment.

Your current rating is **band E (41)**. The average rating for EPCs in Scotland is **band D (59)**.

The potential rating shows the effect of undertaking all of the improvement measures listed within your recommendations report.
