46 PARKHEAD VIEW
PARKHEAD
EDINBURGH
EH11 4RT

Home Report

**Energy
Performance
Certificate**

Scottish Single Survey

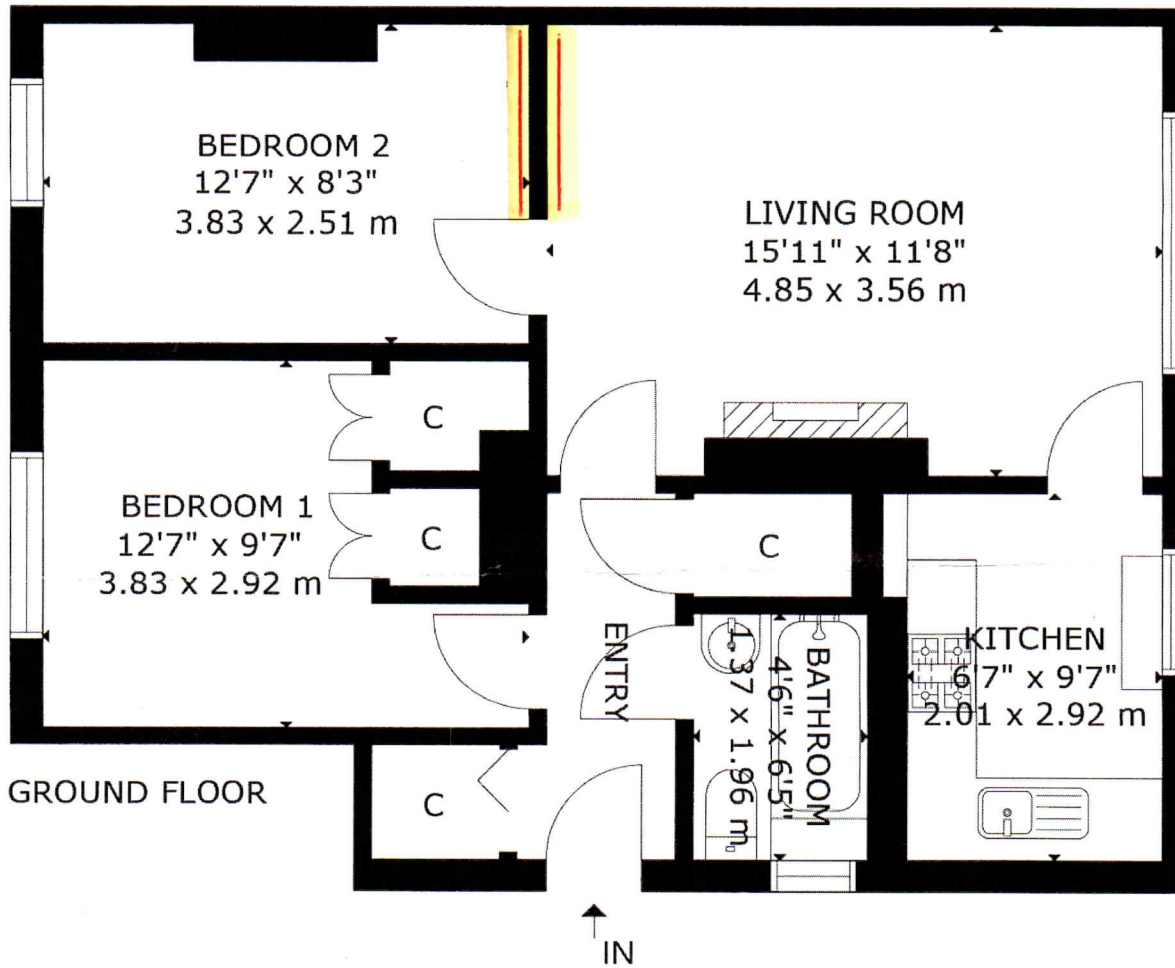
46 PARKHEAD VIEW, EDINBURGH, EH11 4RT
 NOT TO SCALE - FOR ILLUSTRATIVE PURPOSES ONLY
 APPROXIMATE GROSS INTERNAL FLOOR AREA 599 SQ FT / 56 SQ M
 All measurements and fixtures including doors and windows are
 approximate and should be independently verified.
 Copyright © Nest Marketing
 www.nest-marketing.co.uk
