# Home Report

# Single Survey

<b>Property address</b>	76 New Street Musselburgh EH21 6JQ
<b>Customer</b>	Executors of late Jane Banks
<b>Customer address</b>	76 New Street Musselburgh EH21 6JQ
<b>Prepared by</b>	Shepherd Chartered Surveyors
<b>Date of inspection</b>	24/06/2024

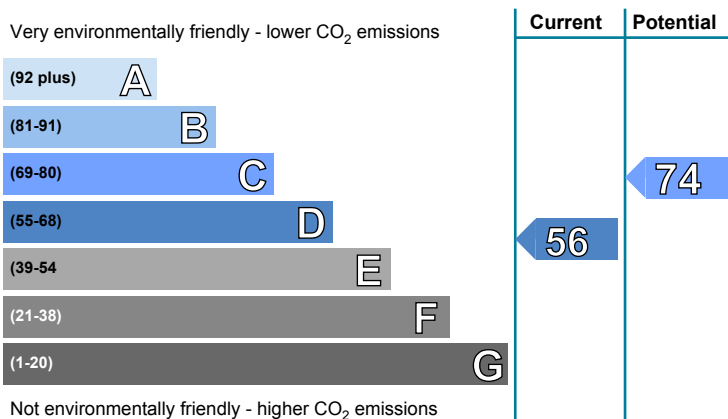
## Environmental Impact (CO<sub>2</sub>) Rating

This graph shows the effect of your home on the environment in terms of carbon dioxide (CO<sub>2</sub>) emissions. The higher the rating, the less impact it has on the environment.
