Home Report

Scottish Single Survey

Property address	104 Macbeth Moir Road Musselburgh EH21 8EE
-------------------------	--

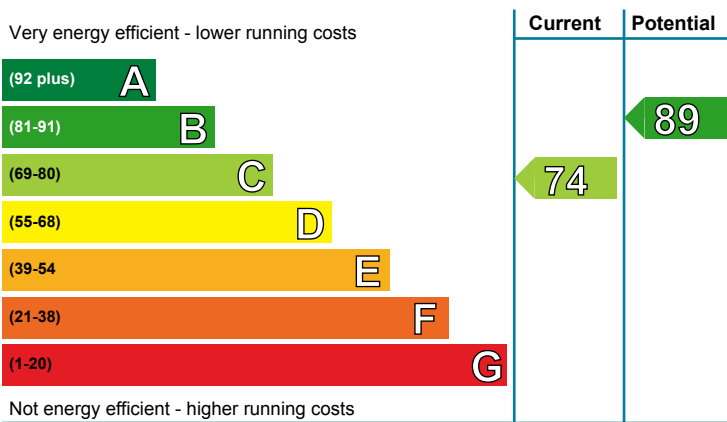
Energy Efficiency Rating

This graph shows the current efficiency of your home, taking into account both energy efficiency and fuel costs. The higher this rating, the lower your fuel bills are likely to be.

Your current rating is **band C (74)**. The average rating for EPCs in Scotland is **band D (61)**.

The potential rating shows the effect of undertaking all of the improvement measures listed within your recommendations report.

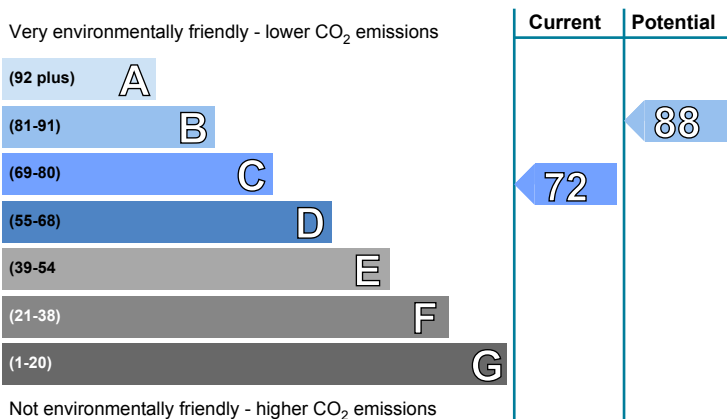
Environmental Impact (CO₂) Rating

This graph shows the effect of your home on the environment in terms of carbon dioxide (CO₂) emissions. The higher the rating, the less impact it has on the environment.
