Home Report

Scottish Single Survey

Single Survey

Property address	37 Stoneybank Avenue Musselburgh EH21 6HN
Customer	Executors of the late Mary Foley
Customer address	37 Stoneybank Avenue Musselburgh EH21 6HN
Prepared by	Shepherd Chartered Surveyors
Date of inspection	25/09/2024

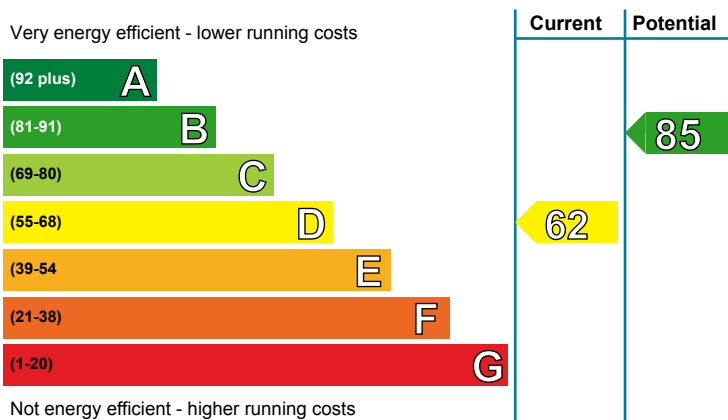
Energy Efficiency Rating

This graph shows the current efficiency of your home, taking into account both energy efficiency and fuel costs. The higher this rating, the lower your fuel bills are likely to be.

Your current rating is **band D (62)**. The average rating for EPCs in Scotland is **band D (61)**.

The potential rating shows the effect of undertaking all of the improvement measures listed within your recommendations report.

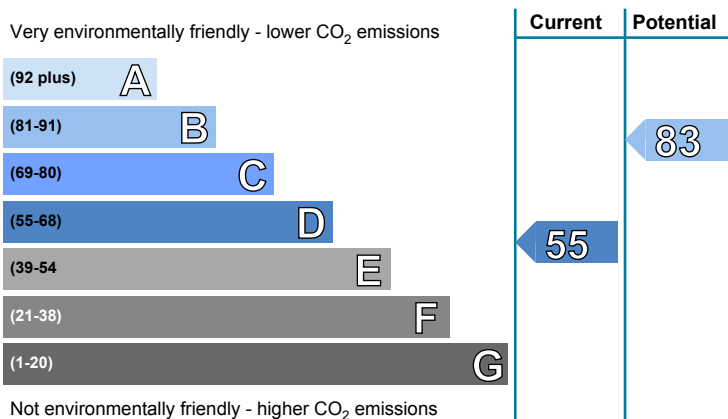
Environmental Impact (CO₂) Rating

This graph shows the effect of your home on the environment in terms of carbon dioxide (CO₂) emissions. The higher the rating, the less impact it has on the environment.
