HOME REPORT

82 South Street
Milnathort
Kinross
KY13 9XB

Single Survey

survey report on:

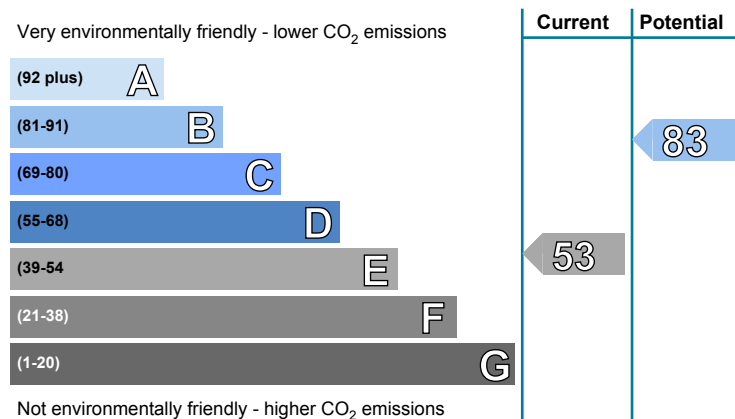
Environmental Impact (CO₂) Rating

This graph shows the effect of your home on the environment in terms of carbon dioxide (CO₂) emissions. The higher the rating, the less impact it has on the environment.
