Home Report

Scottish Single Survey

Single Survey

Property address	5b Market Street Musselburgh EH21 6PS
Customer	Executors of late James Walker
Customer address	5b Market Street Musselburgh EH21 6PS
Prepared by	Shepherd Chartered Surveyors
Date of inspection	11/10/2024

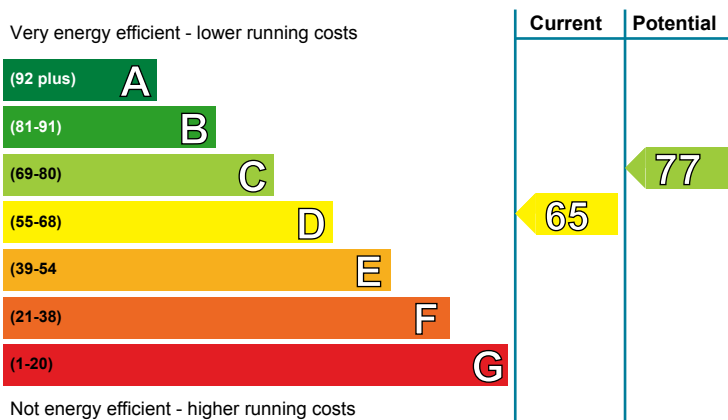
Energy Efficiency Rating

This graph shows the current efficiency of your home, taking into account both energy efficiency and fuel costs. The higher this rating, the lower your fuel bills are likely to be.

Your current rating is **band D (65)**. The average rating for EPCs in Scotland is **band D (61)**.

The potential rating shows the effect of undertaking all of the improvement measures listed within your recommendations report.

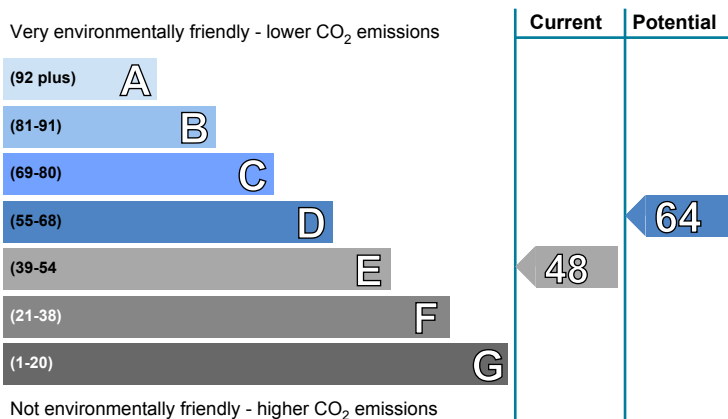
Environmental Impact (CO₂) Rating

This graph shows the effect of your home on the environment in terms of carbon dioxide (CO₂) emissions. The higher the rating, the less impact it has on the environment.
