81 NEWTON CHURCH ROAD
DANDERHALL
DALKEITH
EH22 1LX

# **Home Report**

# survey report on:

Property address	81 NEWTON CHURCH ROAD DANDERHALL DALKEITH EH22 1LX	
Customer	Martyn Chekley and Lee Checkley	
Customer address	81 Newton Church Road Danderhall Dalkeith EH22 1LX	
Prepared by	J&E Shepherd	
Date of inspection	21st October 2024

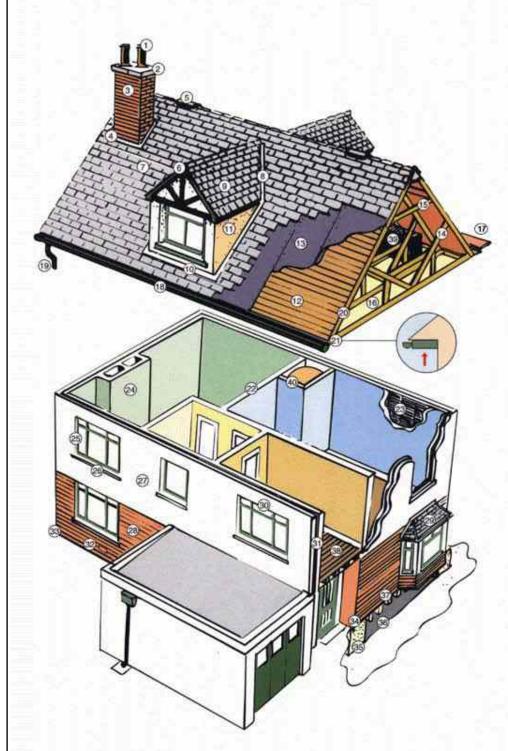
### Sectional Diagram showing elements of a typical house

Reference may be made in this report to some or all of the above component parts of the property. This diagram may assist you in locating and understanding these items.

- 1 Chimney pots
- (2) Coping stone
- 3) Chimney head
- (4) Flashing
- (5) Ridge ventilation
- 6) Ridge board
- 7) Slates / tiles
- (8) Valley guttering
- 9) Dormer projection
- 10 Dormer flashing
- 11) Dormer cheeks
- 12) Sarking
- 13) Roof felt
- (14) Trusses
- (15) Collar
- (16) Insulation
- 17) Parapet gutter
- 18) Eaves guttering
- 19) Rainwater downpipe
- Verge boards /skews
- 21) Soffit boards
- 22) Partition wall
- 23) Lath / plaster
- Latii / plaster
- (24) Chimney breast
- 25) Window pointing
- 26) Window sills
- (27) Rendering
- (28) Brickwork / pointing
- 29) Bay window projection
- (30) Lintels
- (31) Cavity walls / wall ties
- 32) Subfloor ventilator
- 33) Damp proof course
- 34) Base course
- 35) Foundations
- 36) Solum
- 37) Floor joists
- 8 Floorboards
- 39) Water tank
- (40) Hot water tank
