Home Report

Single Survey

Property address	16 Castle Avenue Port Seton Prestonpans EH32 0ES
Customer	Paul Gallagher
Customer address	16 Castle Avenue Port Seton Prestonpans EH32 0ES
Prepared by	Shepherd Chartered Surveyors
Date of inspection	02/10/2024

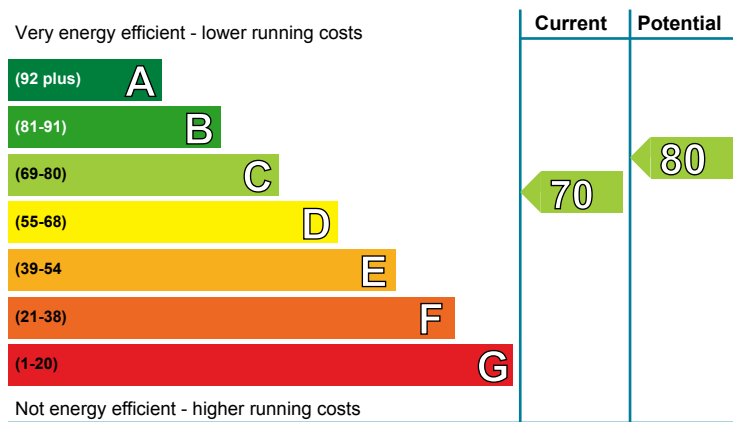
Energy Efficiency Rating

This graph shows the current efficiency of your home, taking into account both energy efficiency and fuel costs. The higher this rating, the lower your fuel bills are likely to be.

Your current rating is **band C (70)**. The average rating for EPCs in Scotland is **band D (61)**.

The potential rating shows the effect of undertaking all of the improvement measures listed within your recommendations report.

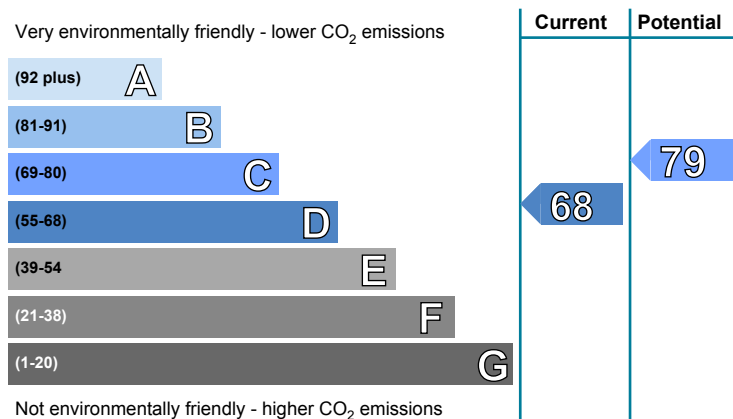
Environmental Impact (CO₂) Rating

This graph shows the effect of your home on the environment in terms of carbon dioxide (CO₂) emissions. The higher the rating, the less impact it has on the environment.
