Home Report

Scottish Single Survey

Property address	43 Stoneybank Gardens South Musselburgh EH21 6NA
-------------------------	--

Prepared by	Shepherd Chartered Surveyors
--------------------	------------------------------

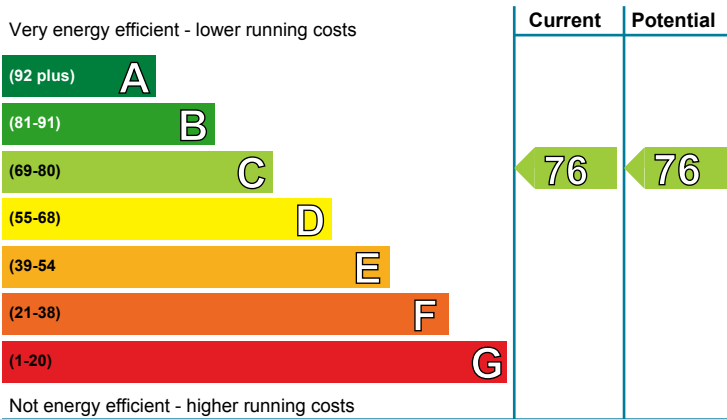
Energy Efficiency Rating

This graph shows the current efficiency of your home, taking into account both energy efficiency and fuel costs. The higher this rating, the lower your fuel bills are likely to be.

Your current rating is **band C (76)**. The average rating for EPCs in Scotland is **band D (61)**.

The potential rating shows the effect of undertaking all of the improvement measures listed within your recommendations report.
