# SCOTTISH SINGLE SURVEY

**6 (1F2) QUEEN'S PARK AVENUE  
EDINBURGH  
EH8 7EE**

**8<sup>th</sup> JANUARY 2025**

**LYNDSAY GOWANS, MRICS**

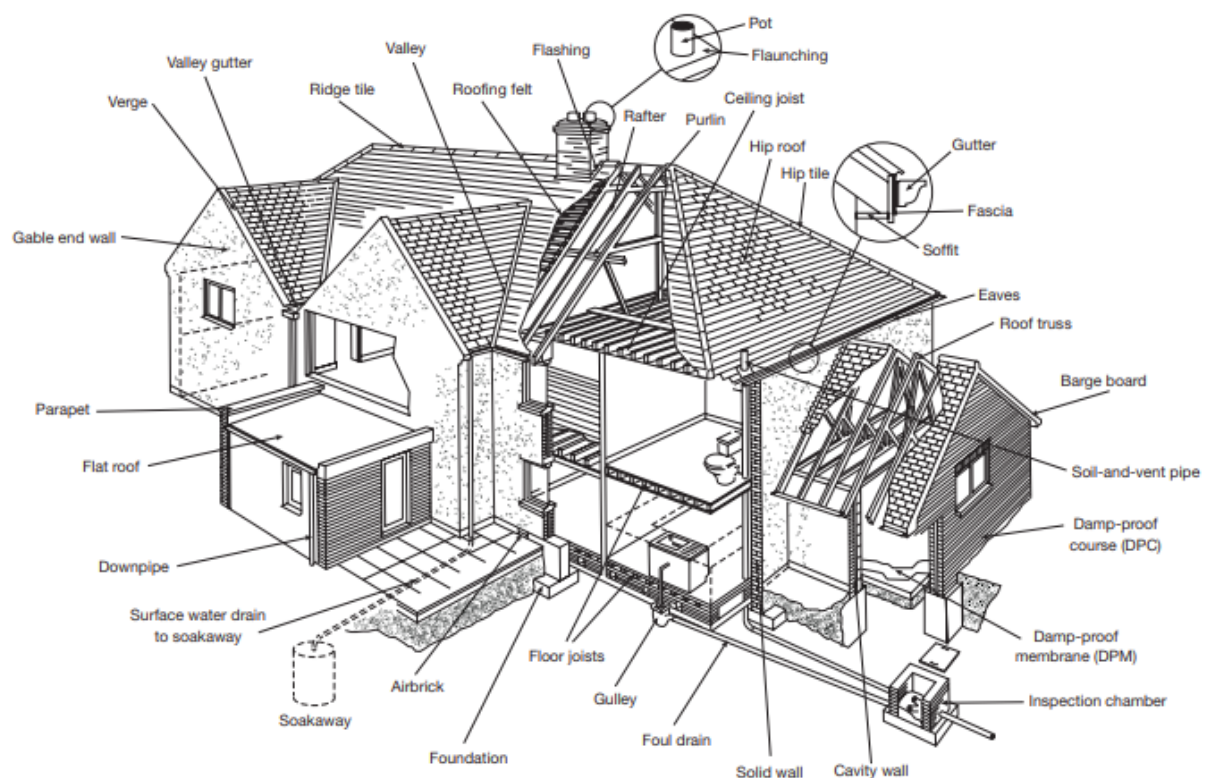
## Sectional diagram showing elements of a typical house

Reference may be made in this report to some or all of the above building elements of the property.

This diagram may assist you in locating and understanding these terms.
