31 WESTBANK PLACE
PORTOBELLO WEST
EDINBURGH
EH15 1UD

Home Report

Energy Performance Certificate (EPC)

Scottish Single Survey

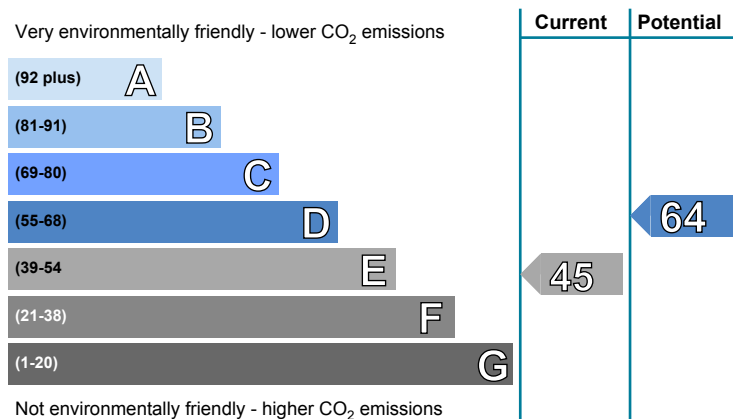
Environmental Impact (CO₂) Rating

This graph shows the effect of your home on the environment in terms of carbon dioxide (CO₂) emissions. The higher the rating, the less impact it has on the environment.

The potential rating shows the effect of undertaking all of the improvement measures listed within your recommendations report.
