45A YORK ROAD TRINITY EDINBURGH EH5 3EG

Home Report

survey report on:

Property address	45A YORK ROAD TRINITY EDINBURGH EH5 3EG	
Customer	Miss Agnes Forrest Executry	
Customer address	45A York Road Trinity Edinburgh EH5 3EG	
Prepared by	J & E Shepherd	
Date of inspection	8th January 2025

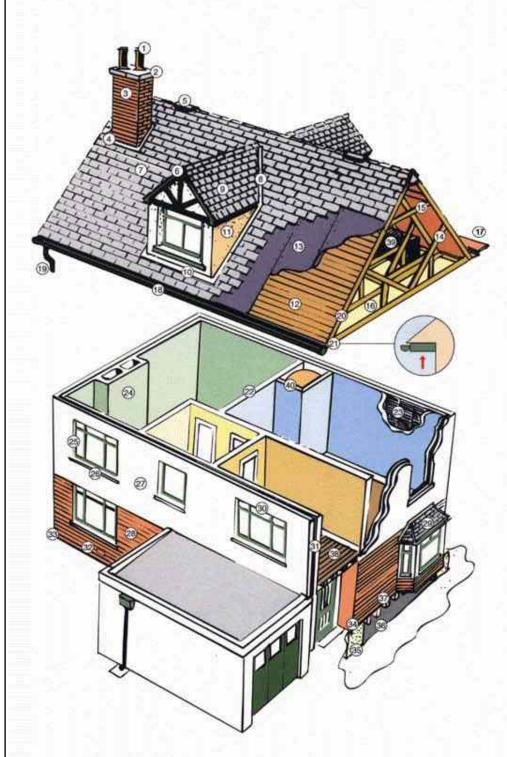
Sectional Diagram showing elements of a typical house

Reference may be made in this report to some or all of the above component parts of the property. This diagram may assist you in locating and understanding these items.

- 1 Chimney pots
- (2) Coping stone
- 3) Chimney head
- 4 Flashing
- (5) Ridge ventilation
- 6) Ridge board
- 7) Slates / tiles
- (8) Valley guttering
- 9) Dormer projection
- 10 Dormer flashing
- 11) Dormer cheeks
- (12) Sarking
- (13) Roof felt
- (14) Trusses
- (15) Collar
- (16) Insulation
- 17) Parapet gutter
- 18) Eaves guttering
- 19) Rainwater downpipe
- Verge boards /skews
- 21) Soffit boards
- 22) Partition wall
- 23) Lath / plaster
- 24) Chimney breast
- \simeq .
- 25) Window pointing
- 26) Window sills
- (27) Rendering
- 28) Brickwork / pointing
- 29 Bay window projection
- (30) Lintels
- (31) Cavity walls / wall ties
- 32) Subfloor ventilator
- 33) Damp proof course
- 34) Base course
- 35) Foundations
- 36) Solum
- Floor joists
- 8) Floorboards
- 9) Water tank
- 40) Hot water tank
