29 PITTVILLE STREET  
PORTOBELLO EAST  
EDINBURGH  
EH15 2BY

# Home Report

# Scottish Single Survey

# Single Survey

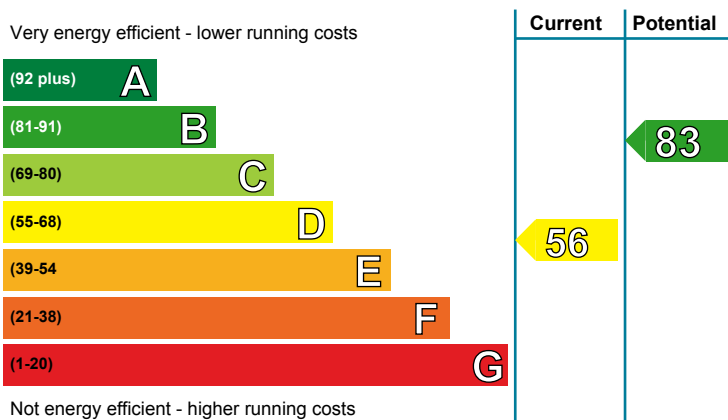
## Energy Efficiency Rating

This graph shows the current efficiency of your home, taking into account both energy efficiency and fuel costs. The higher this rating, the lower your fuel bills are likely to be.

Your current rating is **band D (56)**. The average rating for EPCs in Scotland is **band D (61)**.

The potential rating shows the effect of undertaking all of the improvement measures listed within your recommendations report.

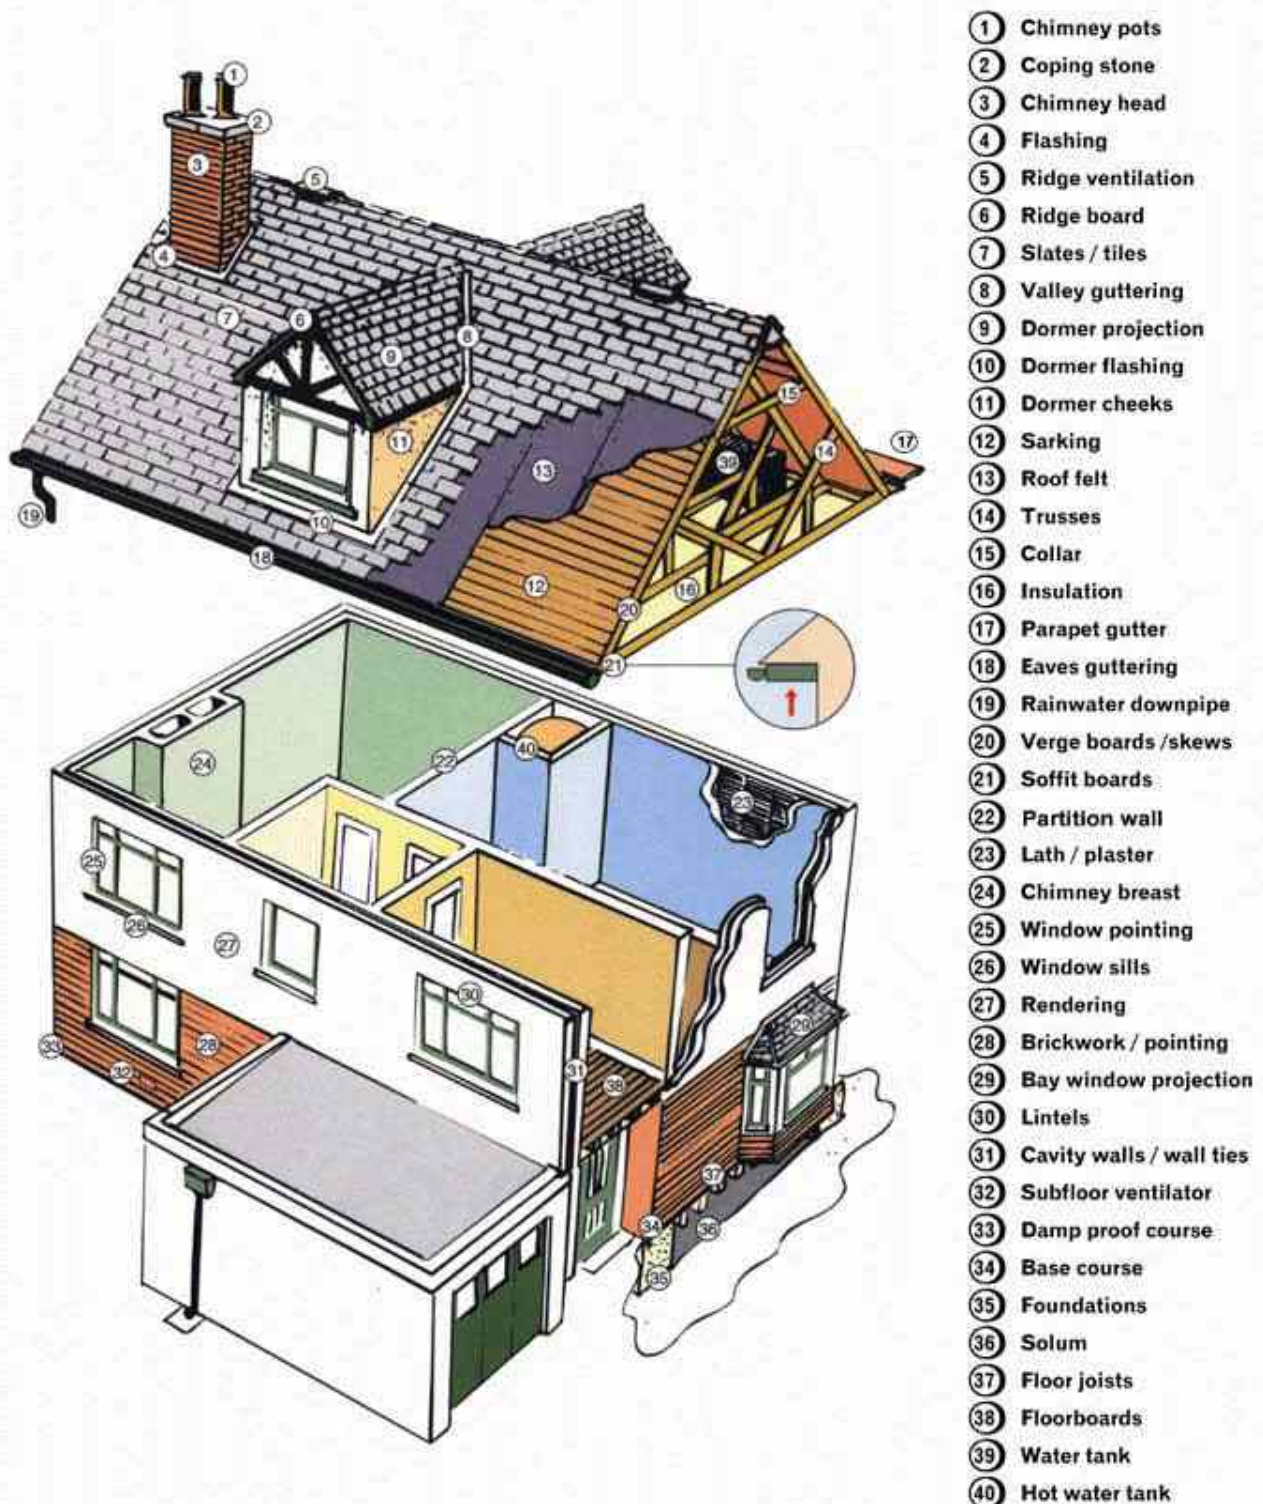
## Sectional Diagram showing elements of a typical house

Reference may be made in this report to some or all of the above component parts of the property. This diagram may assist you in locating and understanding these items.
