Home Report

Single Survey

Property address	87a Great King Street, New Town, Edinburgh, EH3 6RN
-------------------------	--

Prepared by	Allied Surveyors Scotland Ltd
--------------------	-------------------------------

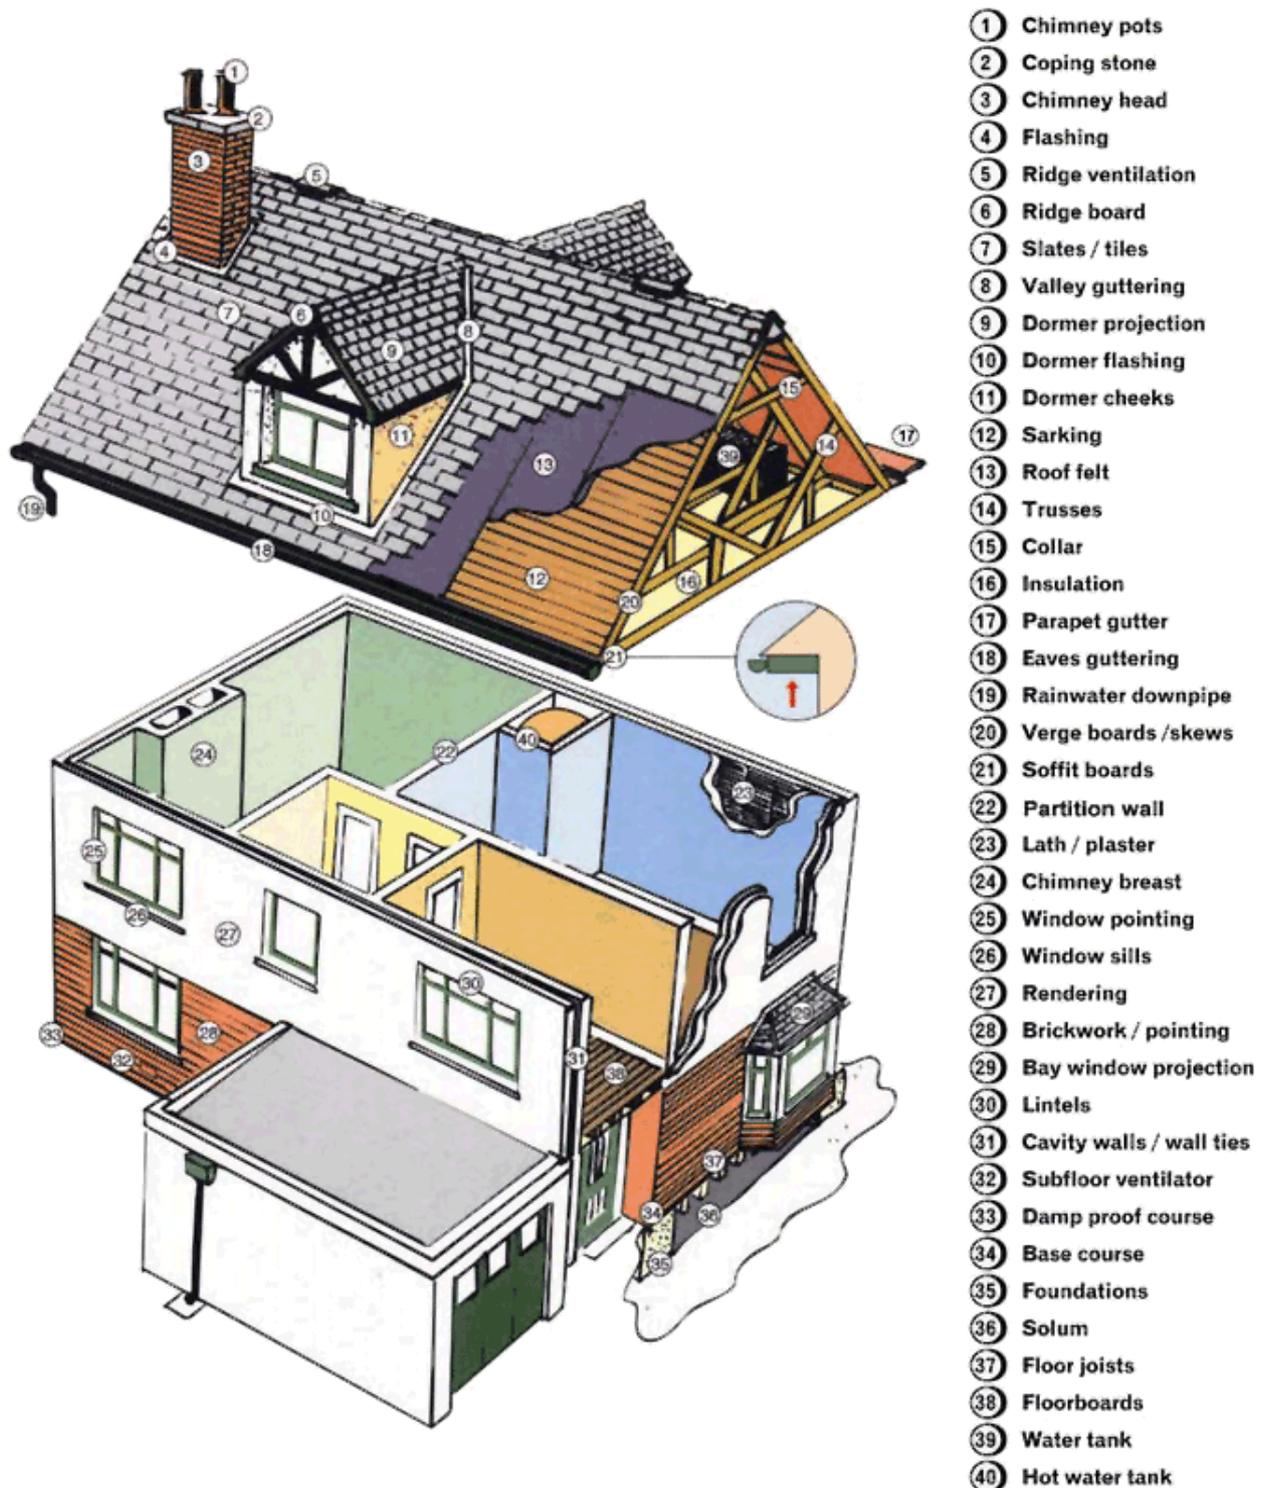
Sectional Diagram showing elements of a typical house

- ① Chimney pots
- ② Coping stone
- ③ Chimney head
- ④ Flashing
- ⑤ Ridge ventilation
- ⑥ Ridge board
- ⑦ Slates / tiles
- ⑧ Valley guttering
- ⑨ Dormer projection
- ⑩ Dormer flashing
- ⑪ Dormer cheeks
- ⑫ Sarking
- ⑬ Roof felt
- ⑭ Trusses
- ⑮ Collar
- ⑯ Insulation
- ⑰ Parapet gutter
- ⑱ Eaves guttering
- ⑲ Rainwater downpipe
- ⑳ Verge boards /skews
- ㉑ Soffit boards
- ㉒ Partition wall
- ㉓ Lath / plaster
- ㉔ Chimney breast
- ㉕ Window pointing
- ㉖ Window sills
- ㉗ Rendering
- ㉘ Brickwork / pointing
- ㉙ Bay window projection
- ㉚ Lintels
- ㉛ Cavity walls / wall ties
- ㉜ Subfloor ventilator
- ㉝ Damp proof course
- ㉞ Base course
- ㉟ Foundations
- ㊱ Solum
- ㊲ Floor joists
- ㊳ Floorboards
- ㊴ Water tank
- ㊵ Hot water tank

Reference may be made in this report to some or all of the above component parts of the property. This diagram may assist you in locating and understanding these items.

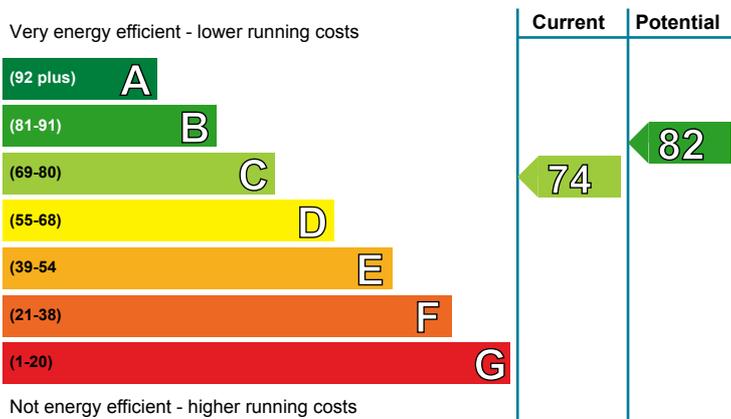
Energy Efficiency Rating

This graph shows the current efficiency of your home, taking into account both energy efficiency and fuel costs. The higher this rating, the lower your fuel bills are likely to be.

Your current rating is **band C (74)**. The average rating for EPCs in Scotland is **band D (61)**.

The potential rating shows the effect of undertaking all of the improvement measures listed within your recommendations report.

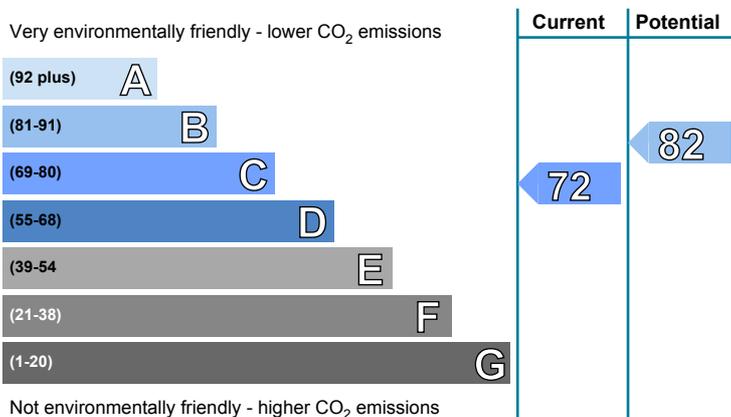
Environmental Impact (CO₂) Rating

This graph shows the effect of your home on the environment in terms of carbon dioxide (CO₂) emissions. The higher the rating, the less impact it has on the environment.
