HOME REPORT

**SCOTTISH SINGLE
SURVEY**

**22 BOSWALL DRIVE
EDINBURGH
EH5 2DX**

7TH MARCH 2025

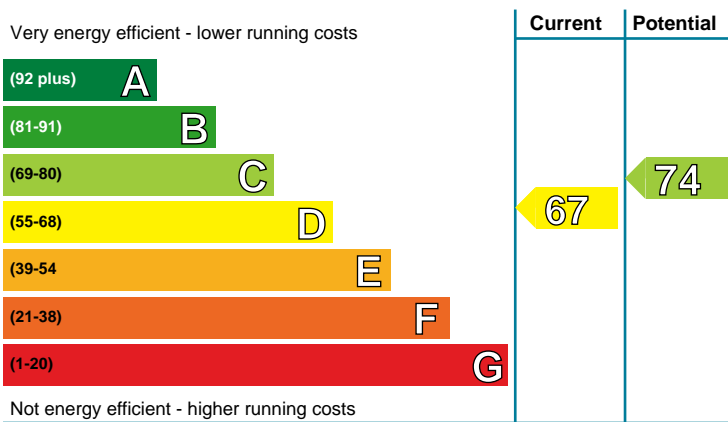
Energy Efficiency Rating

This graph shows the current efficiency of your home, taking into account both energy efficiency and fuel costs. The higher this rating, the lower your fuel bills are likely to be.

Your current rating is **band D (67)**. The average rating for EPCs in Scotland is **band D (61)**.

The potential rating shows the effect of undertaking all of the improvement measures listed within your recommendations report.

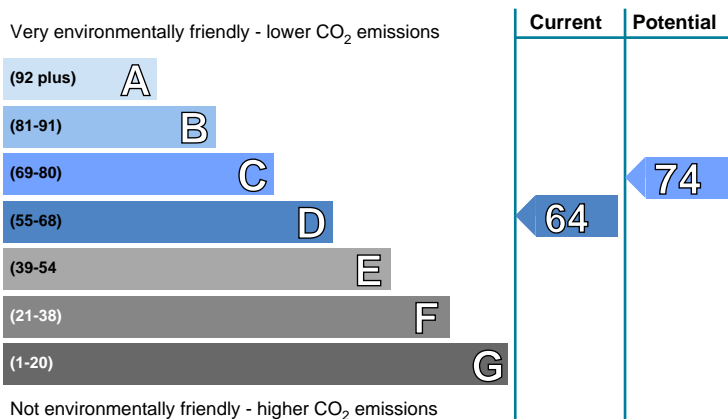
Environmental Impact (CO₂) Rating

This graph shows the effect of your home on the environment in terms of carbon dioxide (CO₂) emissions. The higher the rating, the less impact it has on the environment.
