Home Report

Scottish Single Survey

Property address	91d Inveresk Road Musselburgh EH21 7BE
Customer	Executors of late Iris Christie
Customer address	91d Inveresk Road Musselburgh EH21 7BE
Prepared by	Shepherd Chartered Surveyors
Date of inspection	14/03/2025

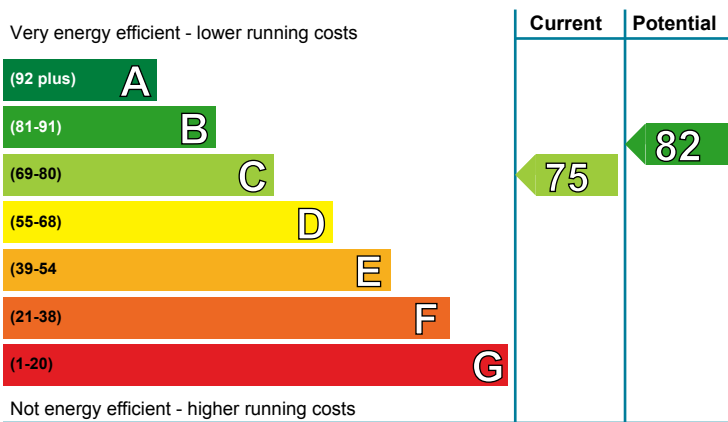
Energy Efficiency Rating

This graph shows the current efficiency of your home, taking into account both energy efficiency and fuel costs. The higher this rating, the lower your fuel bills are likely to be.

Your current rating is **band C (75)**. The average rating for EPCs in Scotland is **band D (61)**.

The potential rating shows the effect of undertaking all of the improvement measures listed within your recommendations report.
