Home Report

Scottish Single Survey

Single Survey

Property address	19 The Paddock Musselburgh EH21 7SP
Customer	Executors of late Karl Vanters
Customer address	19 The Paddock Musselburgh EH21 7SP
Prepared by	Shepherd Chartered Surveyors
Date of inspection	25/03/2025

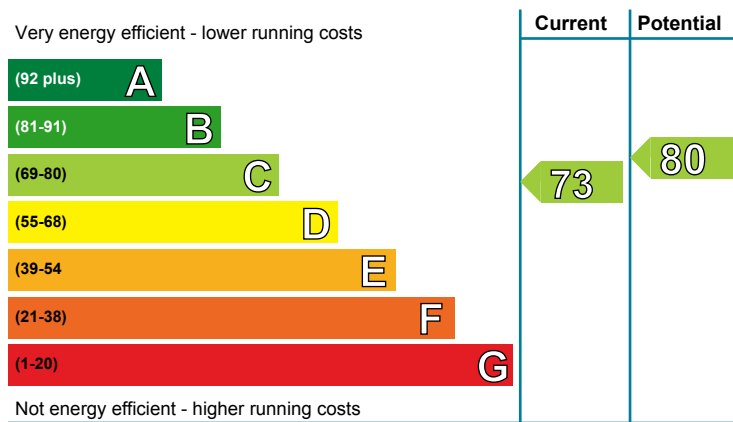
Energy Efficiency Rating

This graph shows the current efficiency of your home, taking into account both energy efficiency and fuel costs. The higher this rating, the lower your fuel bills are likely to be.

Your current rating is **band C (73)**. The average rating for EPCs in Scotland is **band D (61)**.

The potential rating shows the effect of undertaking all of the improvement measures listed within your recommendations report.

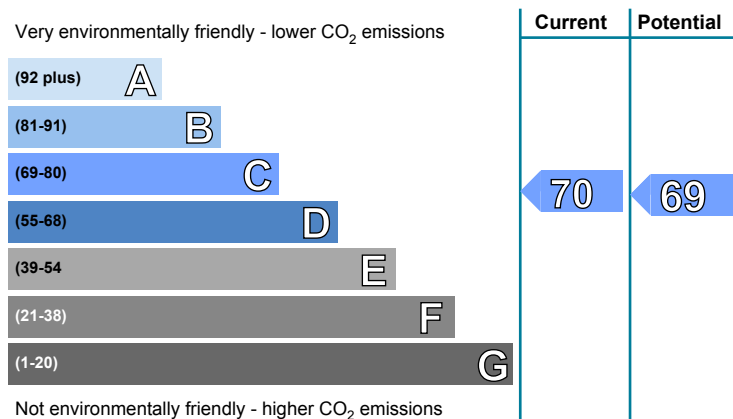
Environmental Impact (CO₂) Rating

This graph shows the effect of your home on the environment in terms of carbon dioxide (CO₂) emissions. The higher the rating, the less impact it has on the environment.
