Home Report

Scottish
Single Survey

Property address	232/3 Craigcrook Road Edinburgh EH4 7TF
Customer	David Renfrew & Nicole Durie
Customer address	232/3 Craigcrook Road Edinburgh EH4 7TF
Prepared by	Shepherd Chartered Surveyors
Date of inspection	29/05/2025

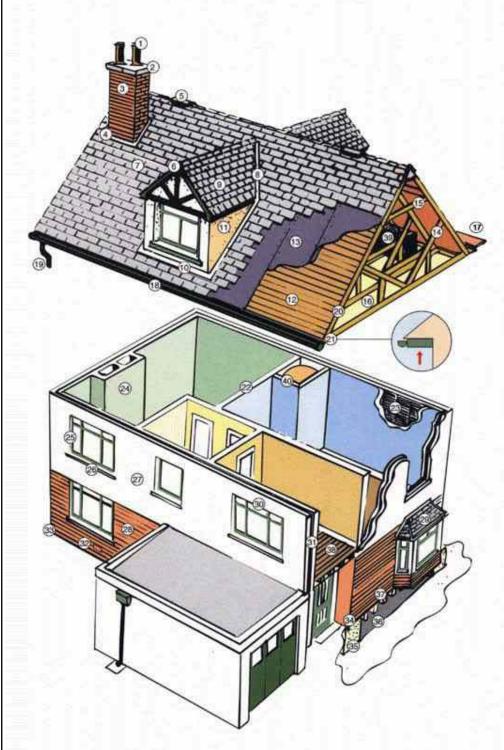
Sectional Diagram showing elements of a typical house

Reference may be made in this report to some or all of the above component parts of the property. This diagram may assist you in locating and understanding these items.

- 1) Chimney pots
- 2) Coping stone
- 3 Chimney head
- (4) Flashing
- 5) Ridge ventilation
- 6 Ridge board
- 7 Slates / tiles
- 8 Valley guttering
- Dormer projection
- 10 Dormer flashing
- 11 Dormer cheeks
- (12) Sarking
- (13) Roof felt
- 14) Trusses
- 15) Collar
- 16) Insulation
- (17) Parapet gutter
- (18) Eaves guttering
- (19) Rainwater downpipe
- 20) Verge boards/skews
- 21) Soffit boards
- 22) Partition wall
- 23) Lath / plaster
- 24) Chimney breast
- 25) Window pointing
- 26) Window sills
- 27) Rendering
- 28) Brickwork / pointing
- 29 Bay window projection
- (30) Lintels
- (31) Cavity walls / wall ties
- 32) Subfloor ventilator
- (33) Damp proof course
- 34) Base course
- (35) Foundations
- 36) Solum
- 37) Floor joists
- 38) Floorboards
- 39) Water tank
- 40) Hot water tank
