Home Report

Scottish
Single Survey

Property address	105b/8 Market Street Musselburgh EH21 6PZ
Customer	Alistair Sime
Customer address	105b/8 Market Street Musselburgh EH21 6PZ
Prepared by	Shepherd Chartered Surveyors
Date of inspection	02/06/2025

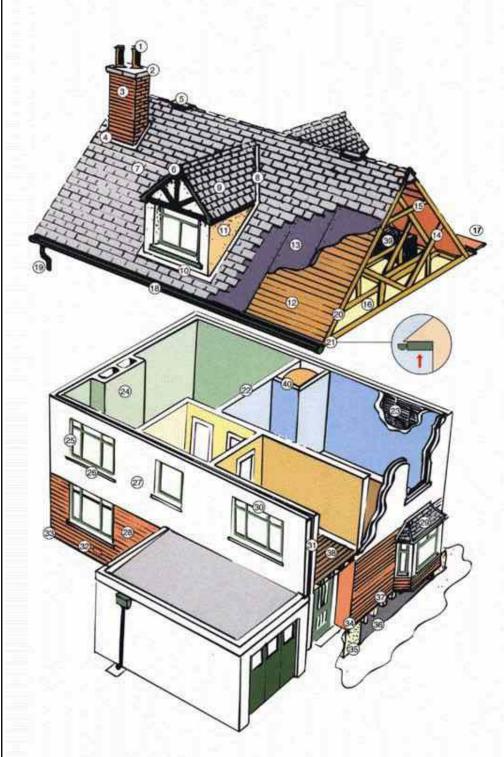
Sectional Diagram showing elements of a typical house

Reference may be made in this report to some or all of the above component parts of the property. This diagram may assist you in locating and understanding these items.

- 1) Chimney pots
- 2) Coping stone
- 3) Chimney head
- (4) Flashing
- 5) Ridge ventilation
- 6) Ridge board
- 7 Slates / tiles
- 8 Valley guttering
- 9 Dormer projection
- 10 Dormer flashing
- 11) Dormer cheeks
- (12) Sarking
- 13) Roof felt
- (14) Trusses
- (15) Collar
- (16) Insulation
- (17) Parapet gutter
- 18) Eaves guttering
- (19) Rainwater downpipe
- 20) Verge boards/skews
- Soffit boards
- 22) Partition wall
- 23) Lath / plaster
- (24) Chimney breast
- 25) Window pointing
- (26) Window sills
- 27) Rendering
- 28) Brickwork / pointing
- 29 Bay window projection
- (30) Lintels
- (31) Cavity walls / wall ties
- 32) Subfloor ventilator
- (33) Damp proof course
- 34) Base course
- 35) Foundations
- 36) Solum
- 7) Floor joists
- 38) Floorboards
- 39) Water tank
- 40) Hot water tank
