# Home Report

87 Caroline Terrace  
Edinburgh EH12 8QX

# Single Survey

| <b>Description</b> | The property comprises an extended two storey detached house. |

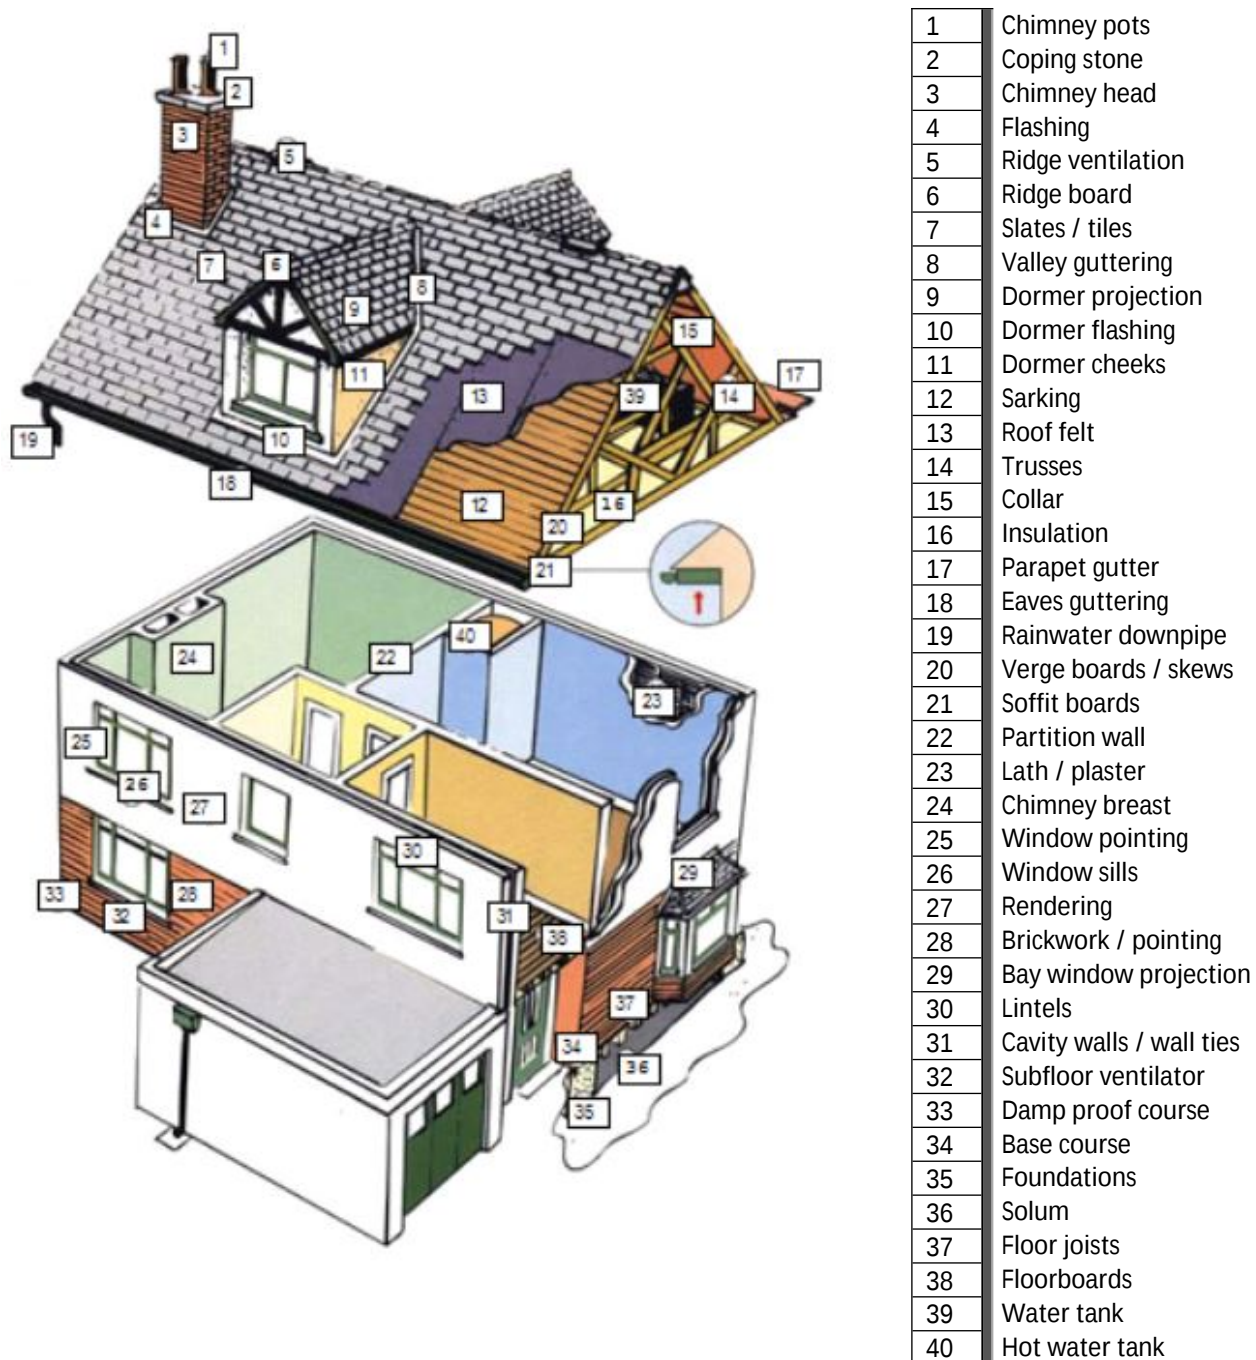
## Sectional diagram showing elements of a typical house

Reference may be made in this report to some or all of the above component parts of the property. This diagram may assist you in locating and understanding these items.
