# HOME REPORT

**SCOTTISH SINGLE  
SURVEY**

**2 PEACOCK COURT  
EDINBURGH  
EH6 4HZ**

**14<sup>TH</sup> JULY 2025**

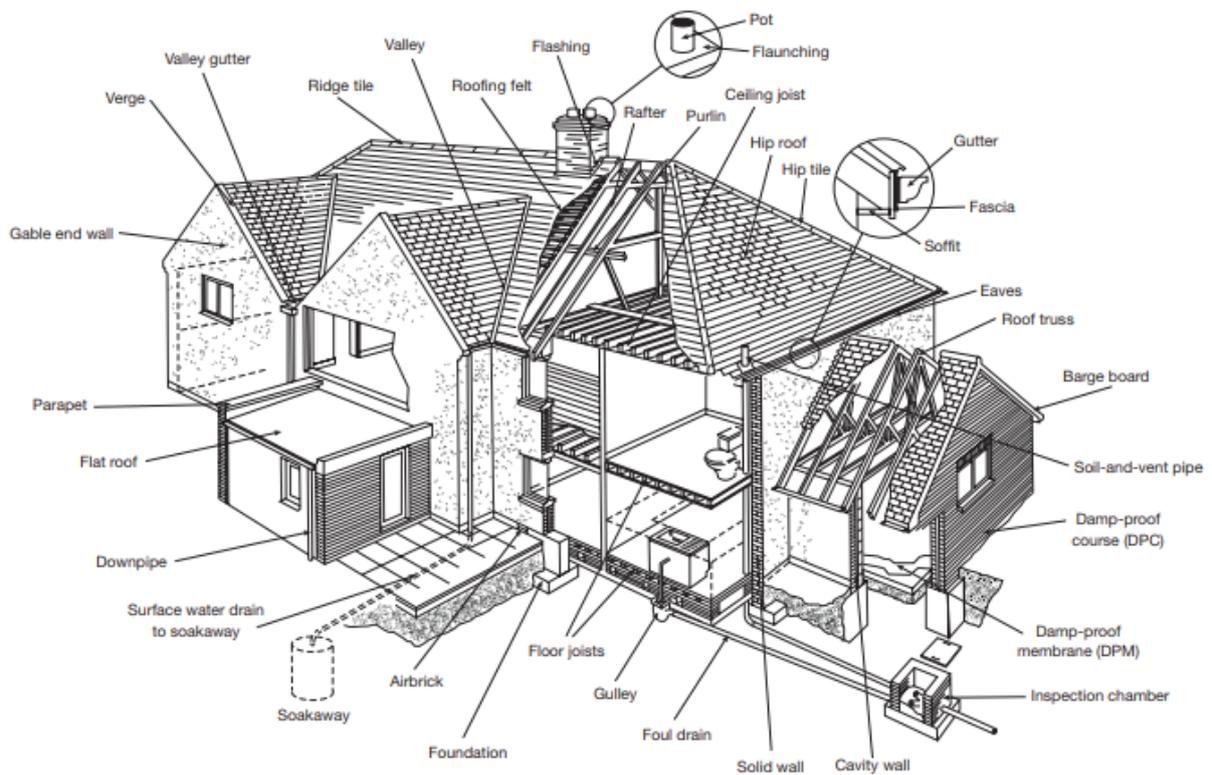
## Sectional diagram showing elements of a typical house

Reference may be made in this report to some or all of the above building elements of the property.

This diagram may assist you in locating and understanding these terms.

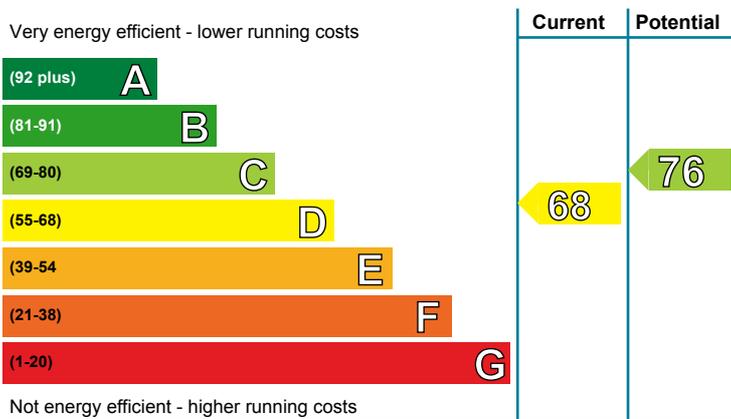
## Energy Efficiency Rating

This graph shows the current efficiency of your home, taking into account both energy efficiency and fuel costs. The higher this rating, the lower your fuel bills are likely to be.

Your current rating is **band D (68)**. The average rating for EPCs in Scotland is **band D (61)**.

The potential rating shows the effect of undertaking all of the improvement measures listed within your recommendations report.

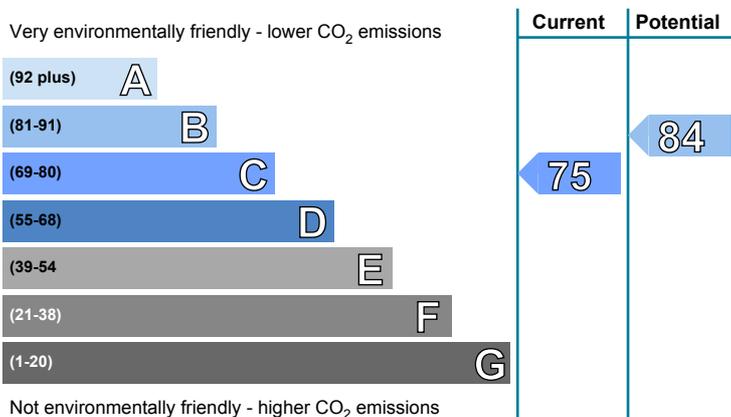
## Environmental Impact (CO<sub>2</sub>) Rating

This graph shows the effect of your home on the environment in terms of carbon dioxide (CO<sub>2</sub>) emissions. The higher the rating, the less impact it has on the environment.
