# Home Report

57/4 Firrhill Drive, Edinburgh, EH13 9EU

# Single Survey

### **Survey Report on:**

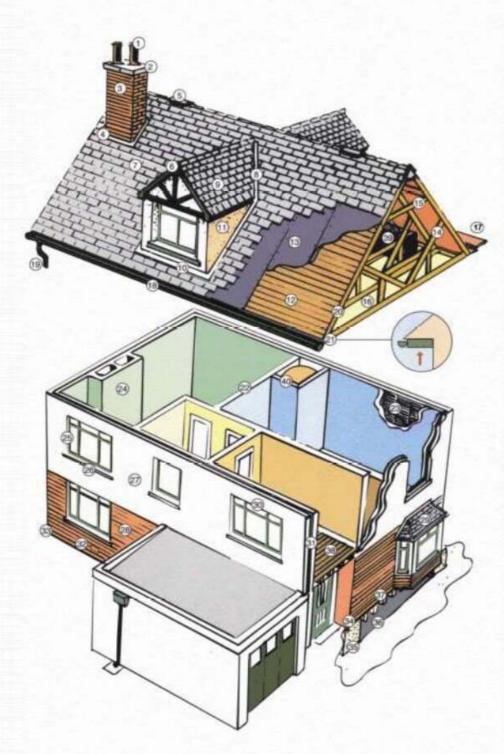
### Sectional Diagram showing elements of a typical house

Reference may be made in this report to some or all of the above component parts of the property. This diagram may assist you in locating and understanding these items.

- 1) Chimney pots
- (2) Coping stone
- 3) Chimney head
- (4) Flashing
- (5) Ridge ventilation
- 6) Ridge board
- (7) Slates / tiles
- (8) Valley guttering
- 9 Dormer projection
- (10) Dormer flashing
- 11) Dormer cheeks
- (12) Sarking
- (13) Roof felt
- (14) Trusses
- (15) Collar
- (16) Insulation
- (17) Parapet gutter
- 18) Eaves guttering
- (19) Rainwater downpipe
- 20 Verge boards /skews
- (21) Soffit boards
- (22) Partition wall
- 23 Lath / plaster
- (24) Chimney breast
- (25) Window pointing
- (26) Window sills
- (27) Rendering
- (28) Brickwork / pointing
- (29) Bay window projection
- (30) Lintels
- (31) Cavity walls / wall ties
- (32) Subfloor ventilator
- (33) Damp proof course
- (34) Base course
- 35) Foundations
- 36) Solum
- (37) Floor joists
- 38) Floorboards
- 39 Water tank
- 40) Hot water tank
