HOME REPORT

SCOTTISH SINGLE SURVEY

**31 HILLSIDE CRESCENT
EDINBURGH
EH7 5EF**

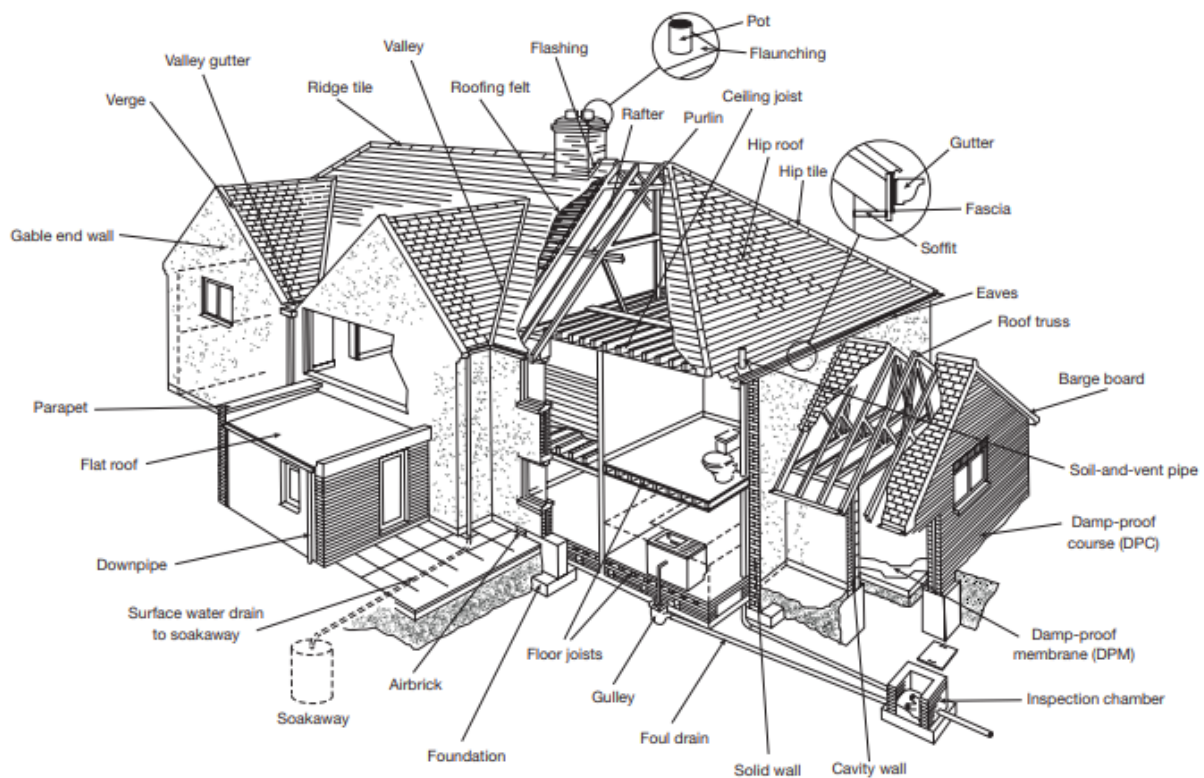
Sectional diagram showing elements of a typical house

Reference may be made in this report to some or all of the above building elements of the property.

This diagram may assist you in locating and understanding these terms.
