# Home Report

# Single Survey

| Property address | 10/2 Southfield Loan<br>Edinburgh<br>EH15 1QR |
| Prepared by | Shepherd Chartered Surveyors |

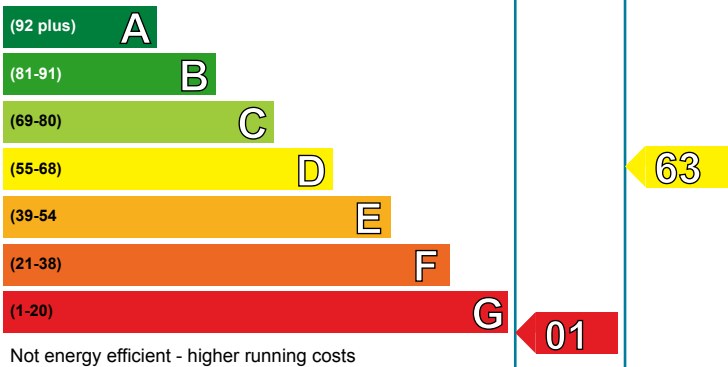
## Energy Efficiency Rating

This graph shows the current efficiency of your home, taking into account both energy efficiency and fuel costs. The higher this rating, the lower your fuel bills are likely to be.

The potential rating shows the effect of undertaking all of the improvement measures listed within your recommendations report.

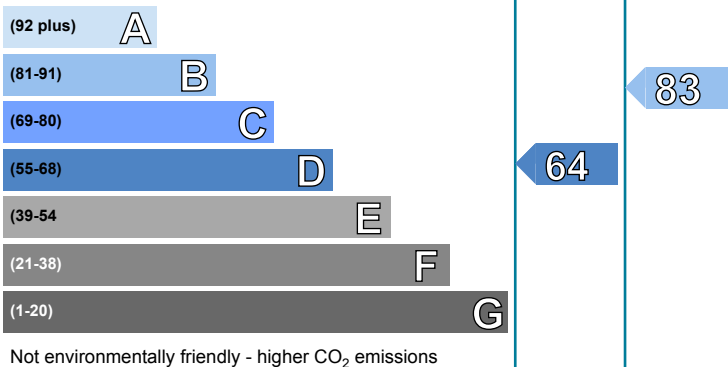
## Environmental Impact (CO<sub>2</sub>) Rating

This graph shows the effect of your home on the environment in terms of carbon dioxide (CO<sub>2</sub>) emissions. The higher the rating, the less impact it has on the environment.
