## HOME REPORT

**15/1 BRIGHT'S CRESCENT  
EDINBURGH  
EH9 2DB**

**25<sup>TH</sup> AUGUST 2025**

**LYNDSAY GOWANS, MA (Hons) MRICS**

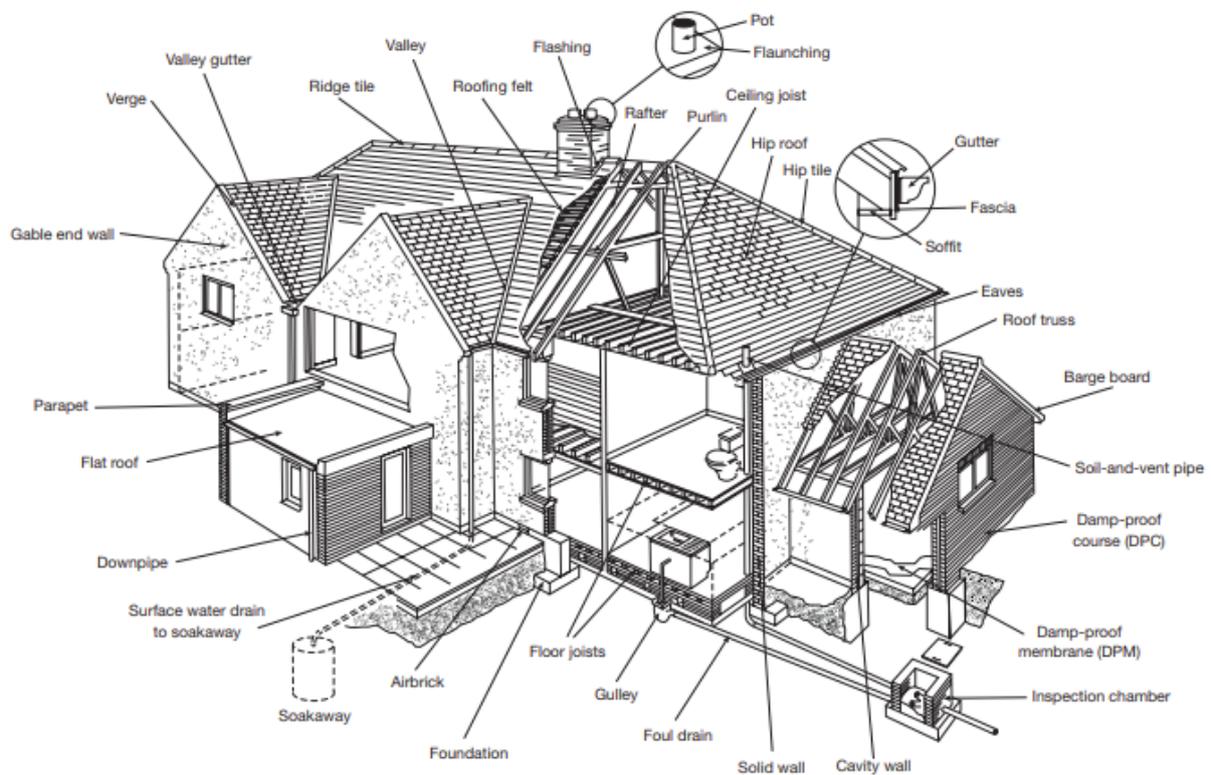
**Sectional diagram showing elements of a typical house**

**Reference may be made in this report to some or all of the above building elements of the property.**

**This diagram may assist you in locating and understanding these terms.**

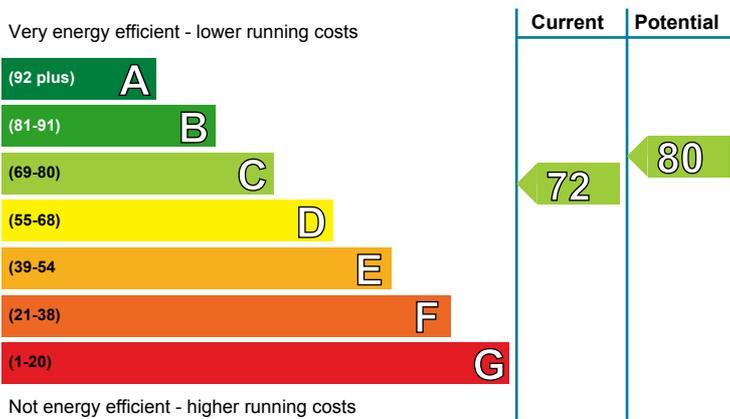
## Energy Efficiency Rating

This graph shows the current efficiency of your home, taking into account both energy efficiency and fuel costs. The higher this rating, the lower your fuel bills are likely to be.

Your current rating is **band C (72)**. The average rating for EPCs in Scotland is **band D (61)**.

The potential rating shows the effect of undertaking all of the improvement measures listed within your recommendations report.
