Home Report

Scottish Single Survey

Property address	23a Market Street Musselburgh EH21 6PS
Customer	Henry Milner-Smith
Customer address	23a Market Street Musselburgh EH21 6PS
Prepared by	Shepherd Chartered Surveyors
Date of inspection	11/11/2025

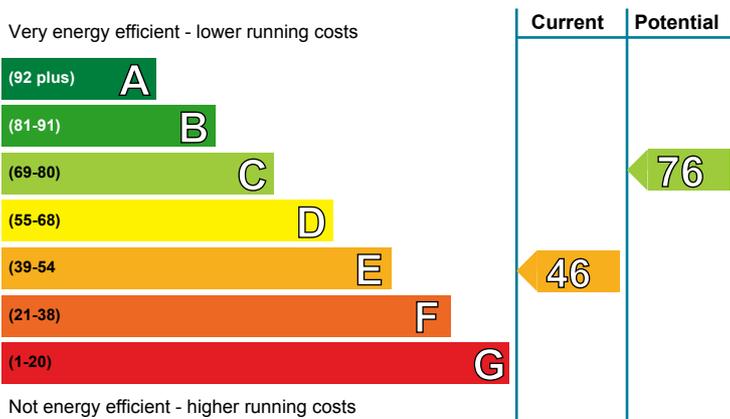
Energy Efficiency Rating

This graph shows the current efficiency of your home, taking into account both energy efficiency and fuel costs. The higher this rating, the lower your fuel bills are likely to be.

Your current rating is **band E (46)**. The average rating for EPCs in Scotland is **band D (61)**.

The potential rating shows the effect of undertaking all of the improvement measures listed within your recommendations report.

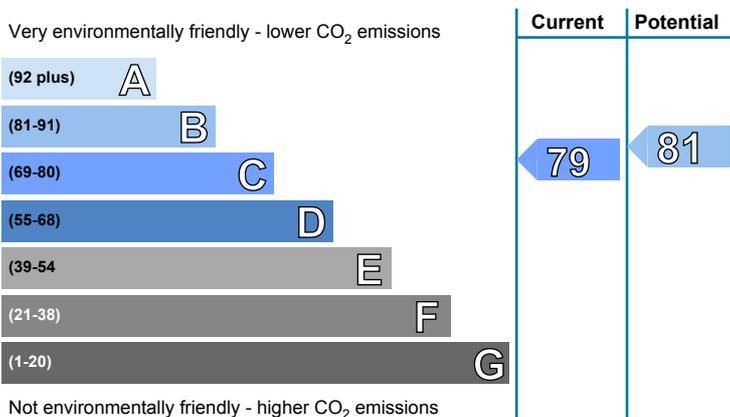
Environmental Impact (CO₂) Rating

This graph shows the effect of your home on the environment in terms of carbon dioxide (CO₂) emissions. The higher the rating, the less impact it has on the environment.
