12 BUCKSTONE DELL  
BUCKSTONE  
EDINBURGH  
EH10 6PG

# Home Report

# Energy Performance Certificate (EPC)

# Single Survey

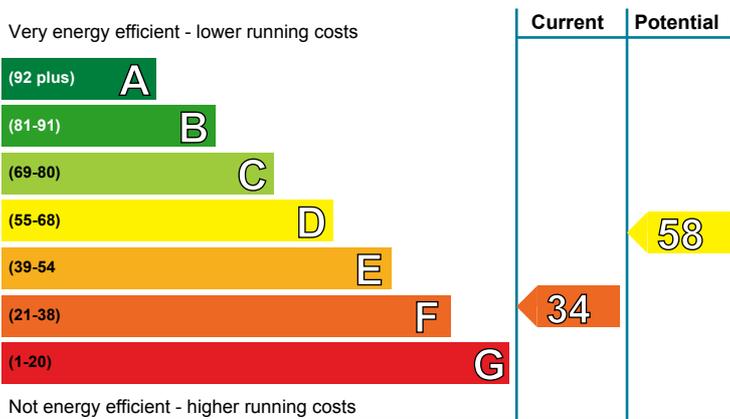
## Energy Efficiency Rating

This graph shows the current efficiency of your home, taking into account both energy efficiency and fuel costs. The higher this rating, the lower your fuel bills are likely to be.

Your current rating is **band F (34)**. The average rating for EPCs in Scotland is **band D (61)**.

The potential rating shows the effect of undertaking all of the improvement measures listed within your recommendations report.

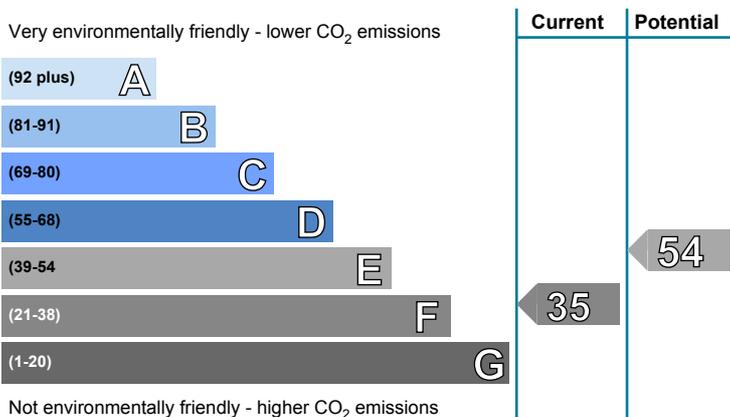
## Environmental Impact (CO<sub>2</sub>) Rating

This graph shows the effect of your home on the environment in terms of carbon dioxide (CO<sub>2</sub>) emissions. The higher the rating, the less impact it has on the environment.

Your current rating is **band F (35)**. The average rating for EPCs in Scotland is **band D (59)**.

The potential rating shows the effect of undertaking all of the improvement measures listed within your recommendations report.
