HOME REPORT

10 An Gleann Apartments
Main Street
Glenfarg
Perth
PH2 9FY

Single Survey

Survey Report on:

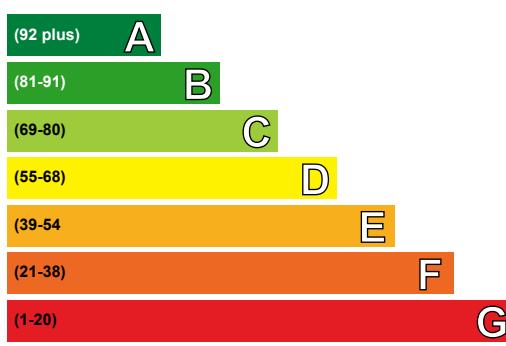
Energy Efficiency Rating

Very energy efficient - lower running costs

Not energy efficient - higher running costs

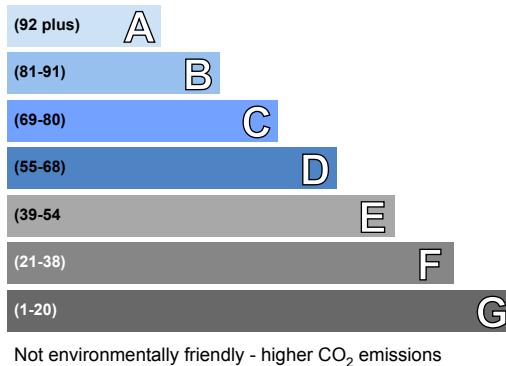
Environmental Impact (CO₂) Rating

Very environmentally friendly - lower CO₂ emissions
